The Archaeology of Monticello's South Pavilion and South Wing

By
Crystal O'Connor and Fraser Neiman
Monticello Department of Archaeology

Monticello Department of Archaeology Technical Report Series Number 7

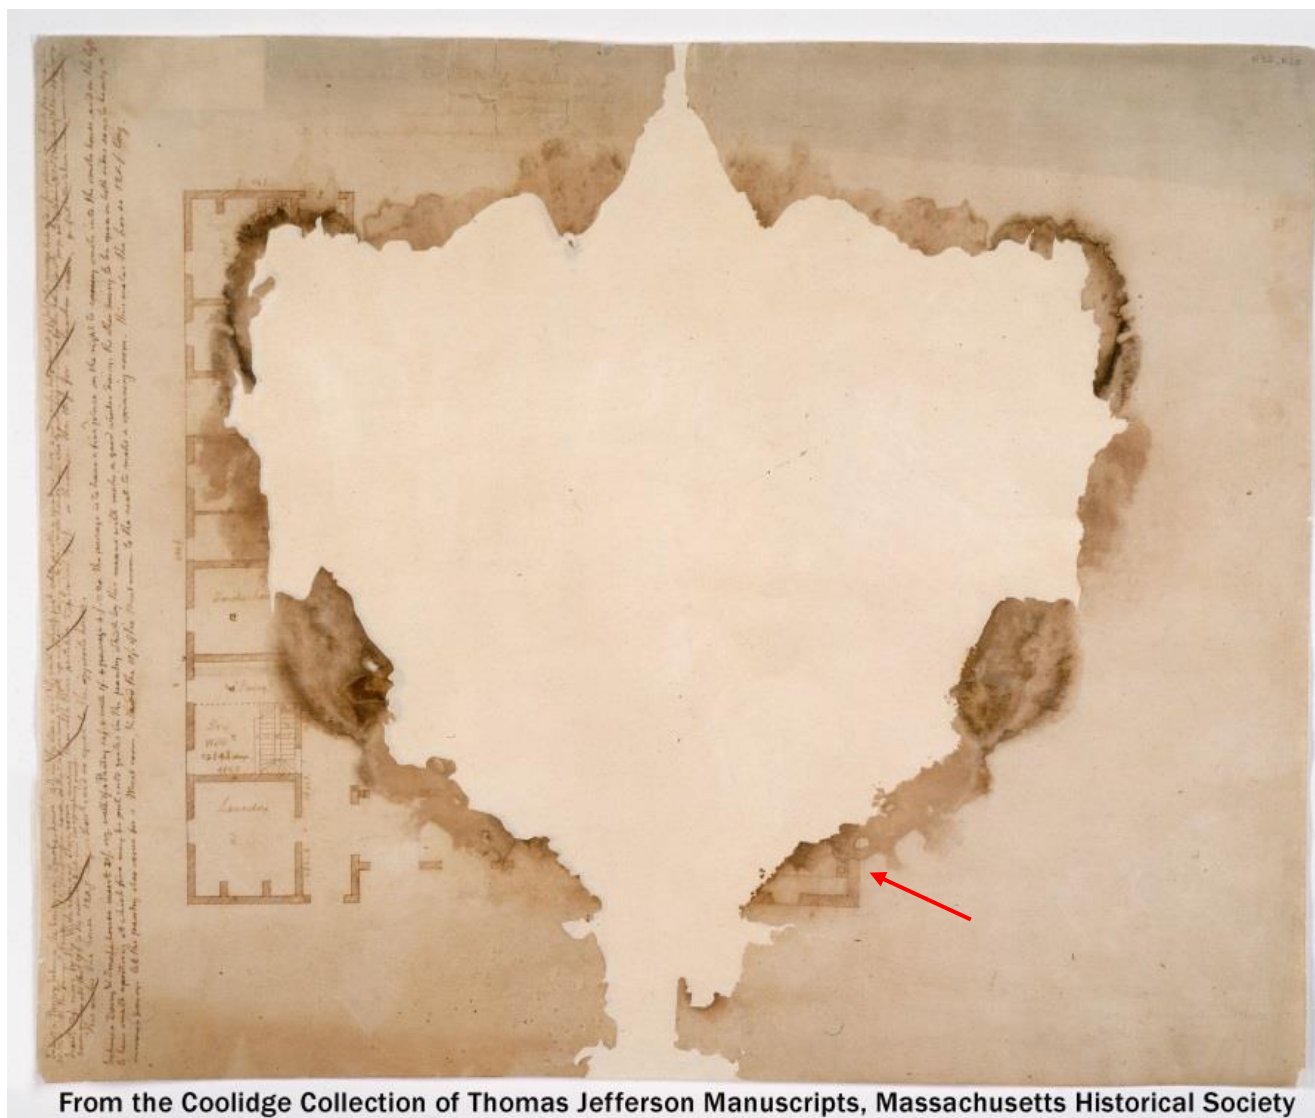
Figure 3: N32 recto (Jefferson 1768-1770a). Document is badly burned but shows a kitchen with at least three holes for a stew stove along with a dresser running along the north wall (see red arrow). This is the measured drawing of N59 (Figure 2).

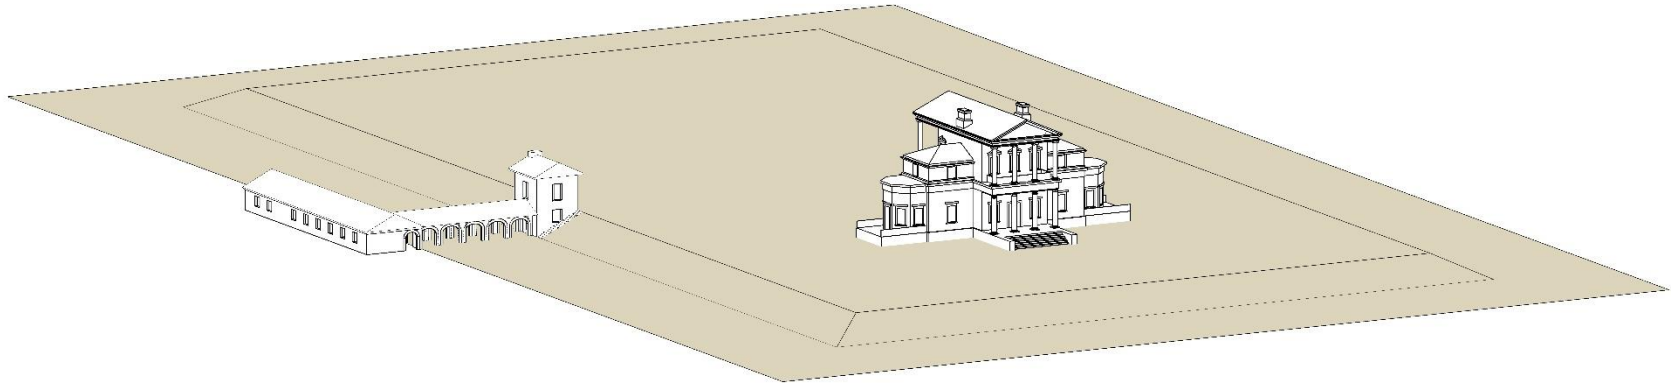
Figure 4: Composite schematic of N59, N32, and N34. Shows the imagined terrace with Monticello I, South Pavilion, arcade, and dependency wing. See Mesick Cohen Waite 1991:10 for the imagined arcade.

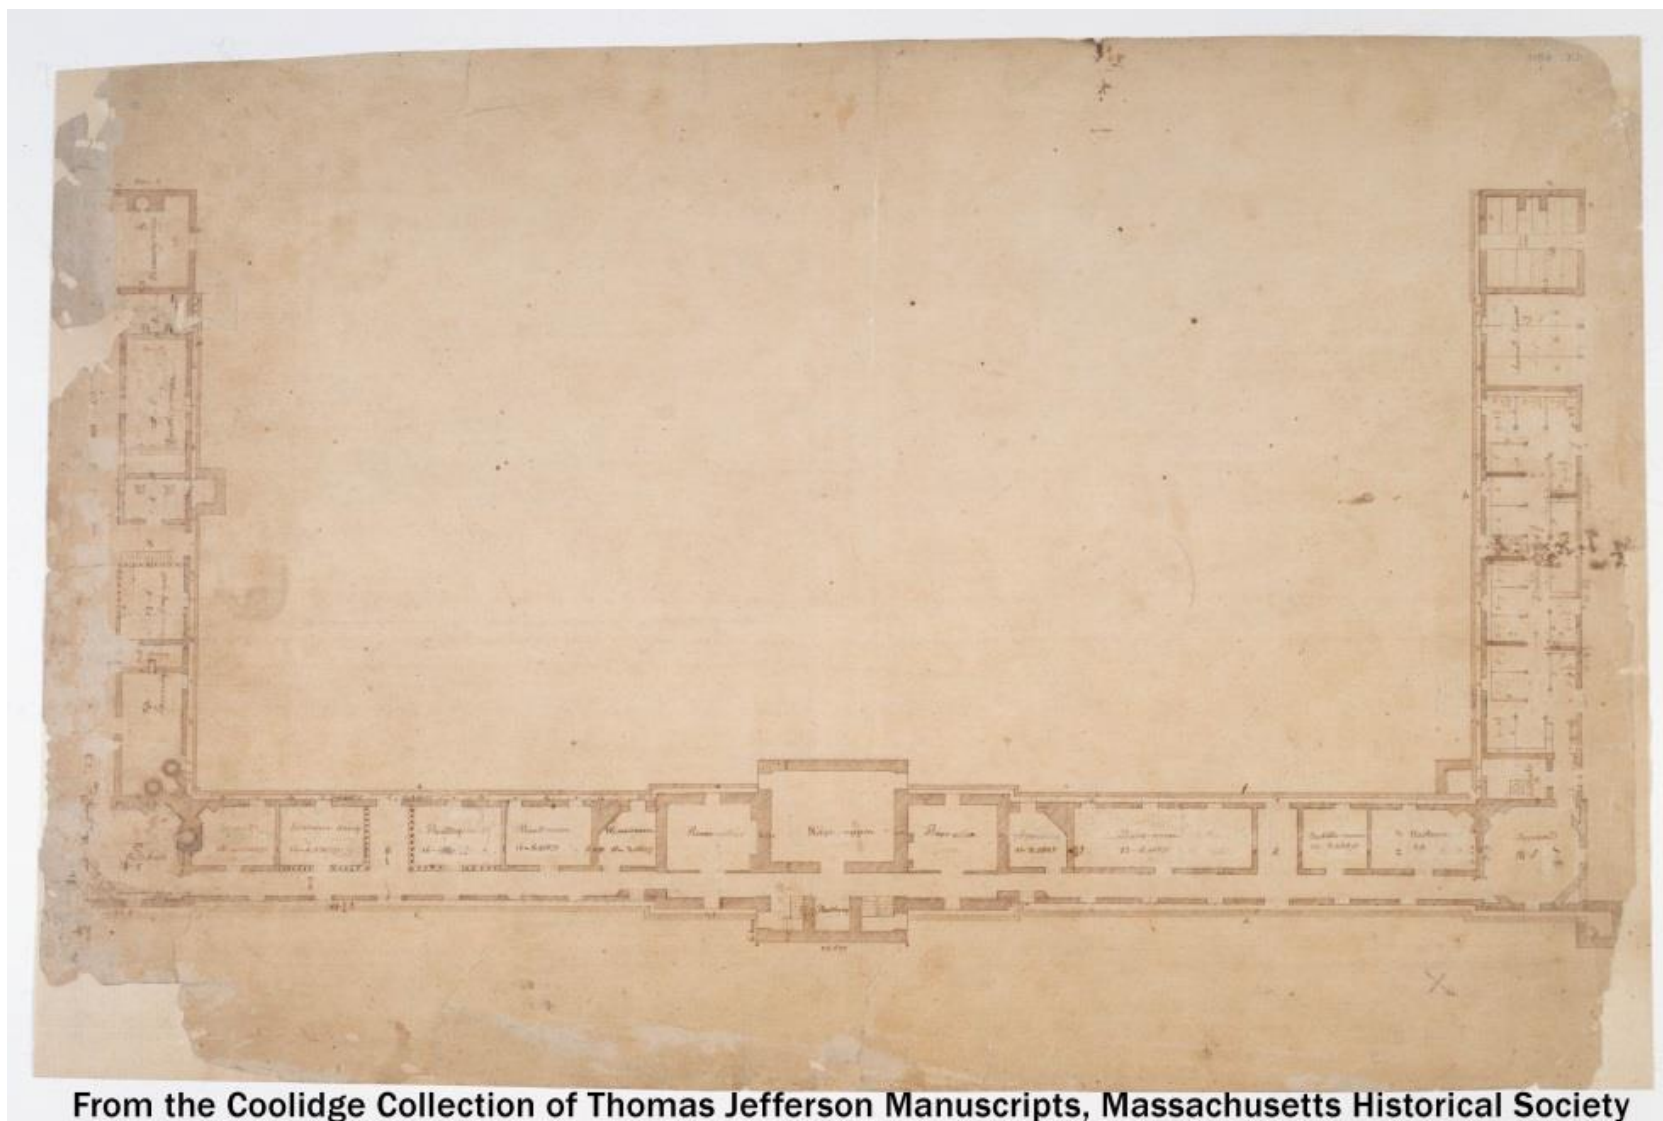
Figure 6: N56, before August 4, 1772 (Jefferson n.d.b). L-shaped wings extend from a centrally located main house. A seven-burner stew stove is labeled in the kitchen in the bottom left corner. Also included are the dimensions of the South Pavilion in what is labeled the "Brewing Room" at the end of the South Wing.

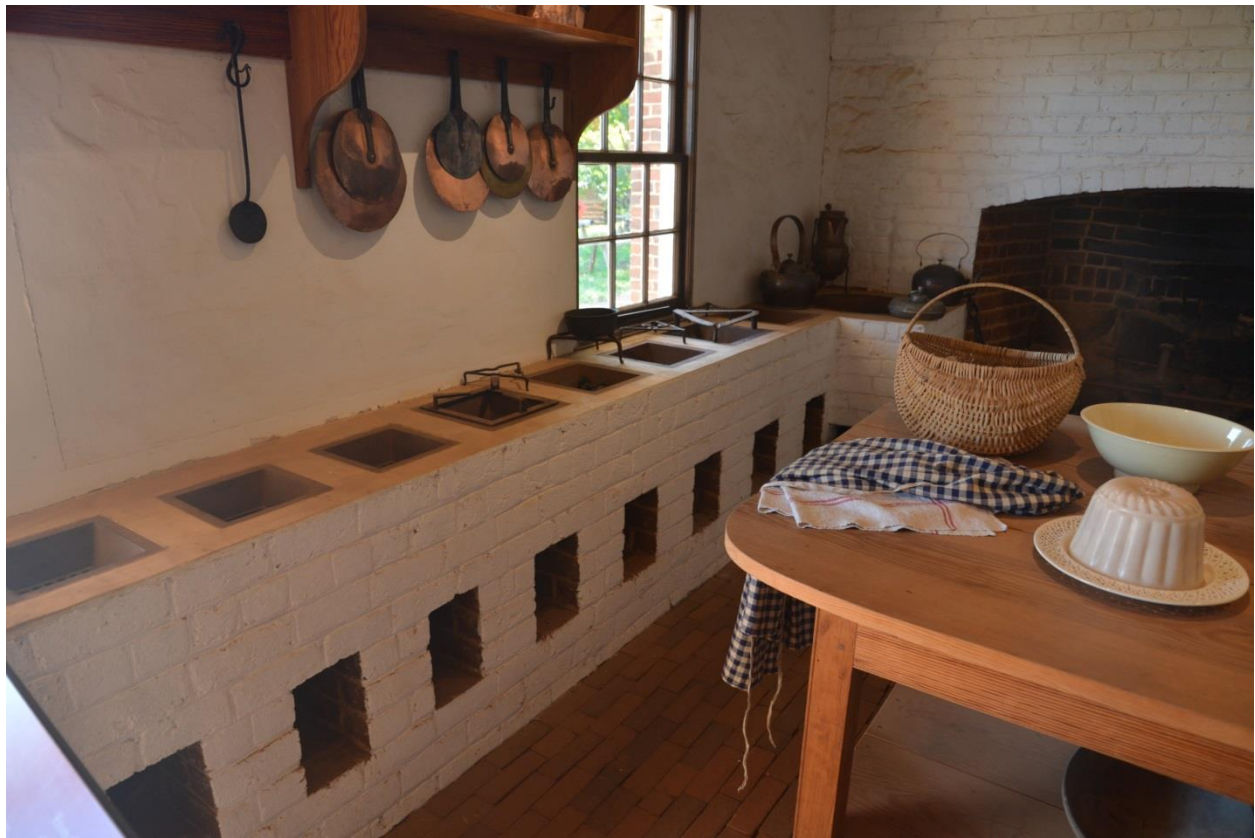
Figure 9: The reconstructed stew stoves in the 1809 kitchen in the South Wing at Monticello. Note the holes on top, on which a trivet was placed to hold a pot. The cleanouts were below.

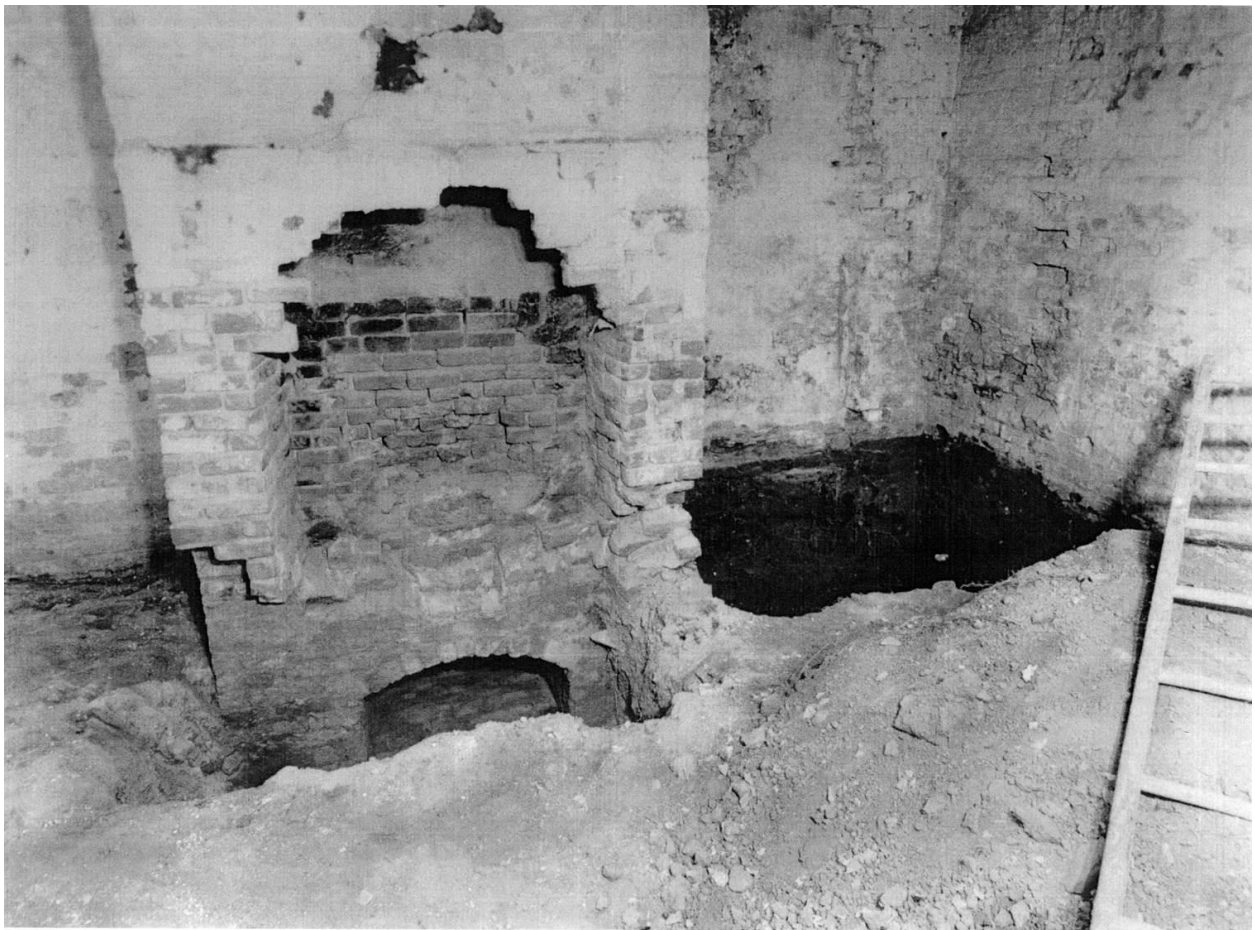
Figure 14: Photograph of Grigg's exploratory excavations in the South Pavilion (Grigg 1941m).

Restoration architect Milton L. Grigg conducted the earliest excavations in the South Pavilion and South Wing in the 1940s ahead of renovations of the spaces. A photograph from inside the Pavilion shows that he excavated three zones: in the northwest corner, in front of the central fireplace dating to the washroom conversion in 1809, and along the south wall (Figure 14). Grigg produced a map and a few notes documenting his work, including relative elevations (Figure 15, Figure 34).

The final feature in this first Period is the brick arch between the cheek walls that supported the upstairs fireplace. The 2016 excavations did not reopen Grigg's test pit in front of the fireplace. However, Grigg's 1941 photograph and notes recorded this arch (Figure 14, Figure 34). He noted that there was no flue above the arch. This is a critical piece of evidence. It implies

Access from the second floor to the kitchen was possible via a set of brick stairs that ran from the West Lawn down the east side of the Pavilion. Discovered below grade by Milton Grigg in the early 1940s, the steps went at least to the southeast corner of the Pavilion (Figure 14). The 2016 excavations relocated a portion of the stairs on the exterior of the eastern wall; however, excavations did not extend further south under the existing brick pathway, so we could not confirm Grigg's observations about the southern edge of the stairs.

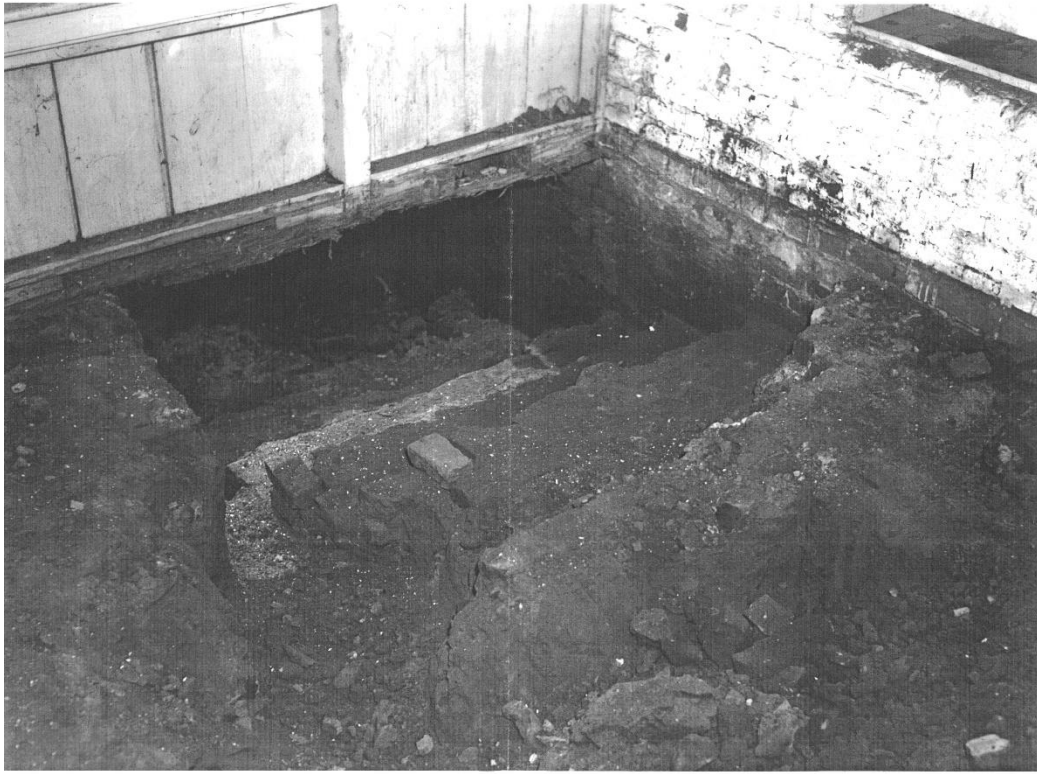
Figure 16: Photograph of Grigg’s exploratory excavations in the South Wing (Grigg 1941n). Pictured are the brick steps which led from the door of the South Pavilion to the West Lawn. The brick wall to the right is the east wall of the South Pavilion. View southwest.

Along the exterior of the east wall of the Pavilion, Grigg found brick steps which predate the construction of the Wing and led from the southeast corner of the Pavilion up to the West Lawn (Figure 16). He identified the bricked-in original window on the east wall of the Pavilion. Grigg excavated outside of the building’s southern window to test whether the opening was actually a door when the space functioned as a kitchen and found an “unexplained landing or platform at the base of a bricked-up opening” (Grigg 1941d, 1941e).

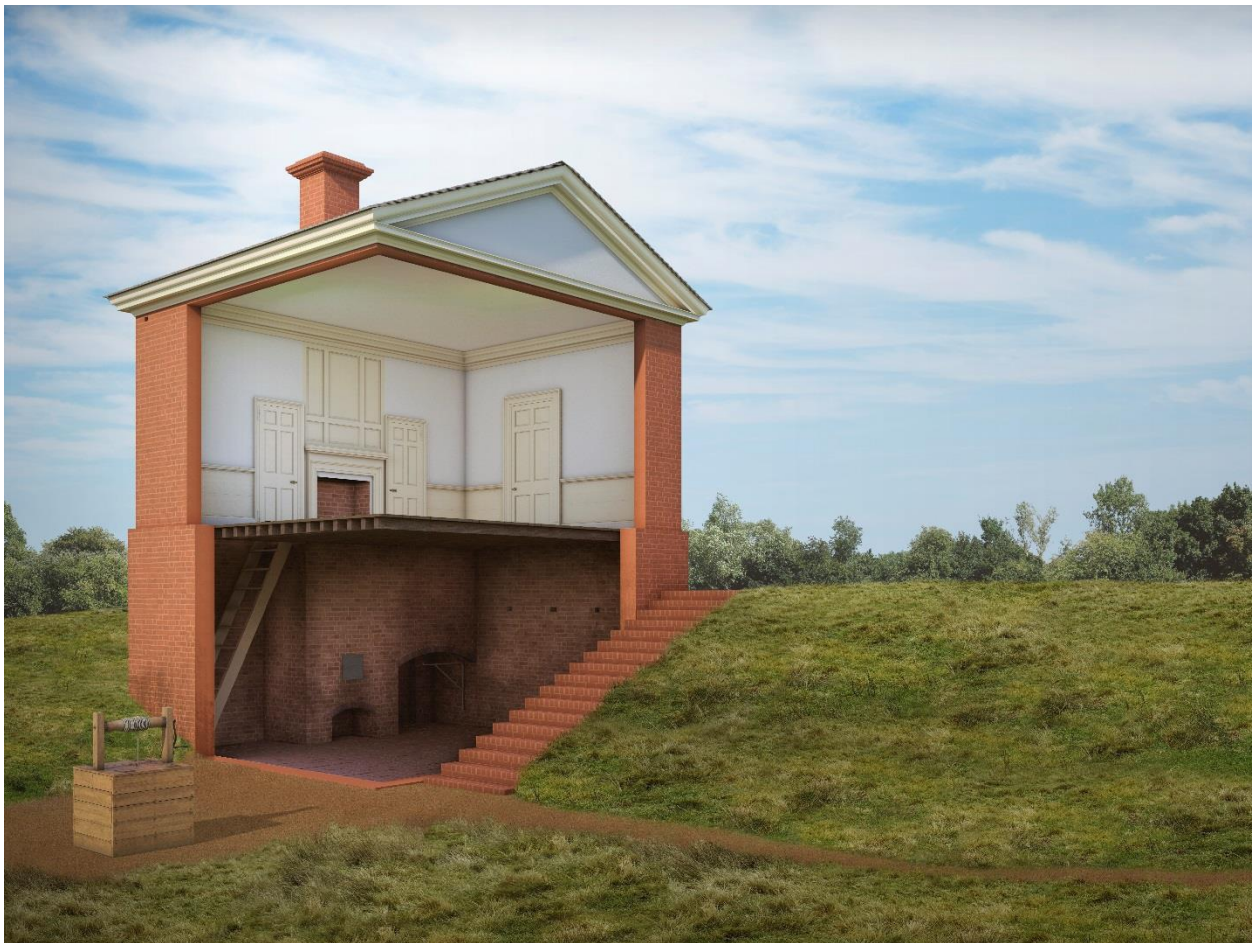
Figure 22: Period 1 South Pavilion digital rendering (RenderSphere 2017a). View northwest.

documented events. Features related to the earliest version of the kitchen include a fireplace in the northwest corner, a floor consisting of brick pavers, evidence for an earlier stew stove along the north wall, stairs or a ladder in the southwest corner, a bake oven along the west wall, and a dresser along the east wall (Figure 22, Figure 23). Table 2 lists the stratigraphic groups and features included in Period 1.

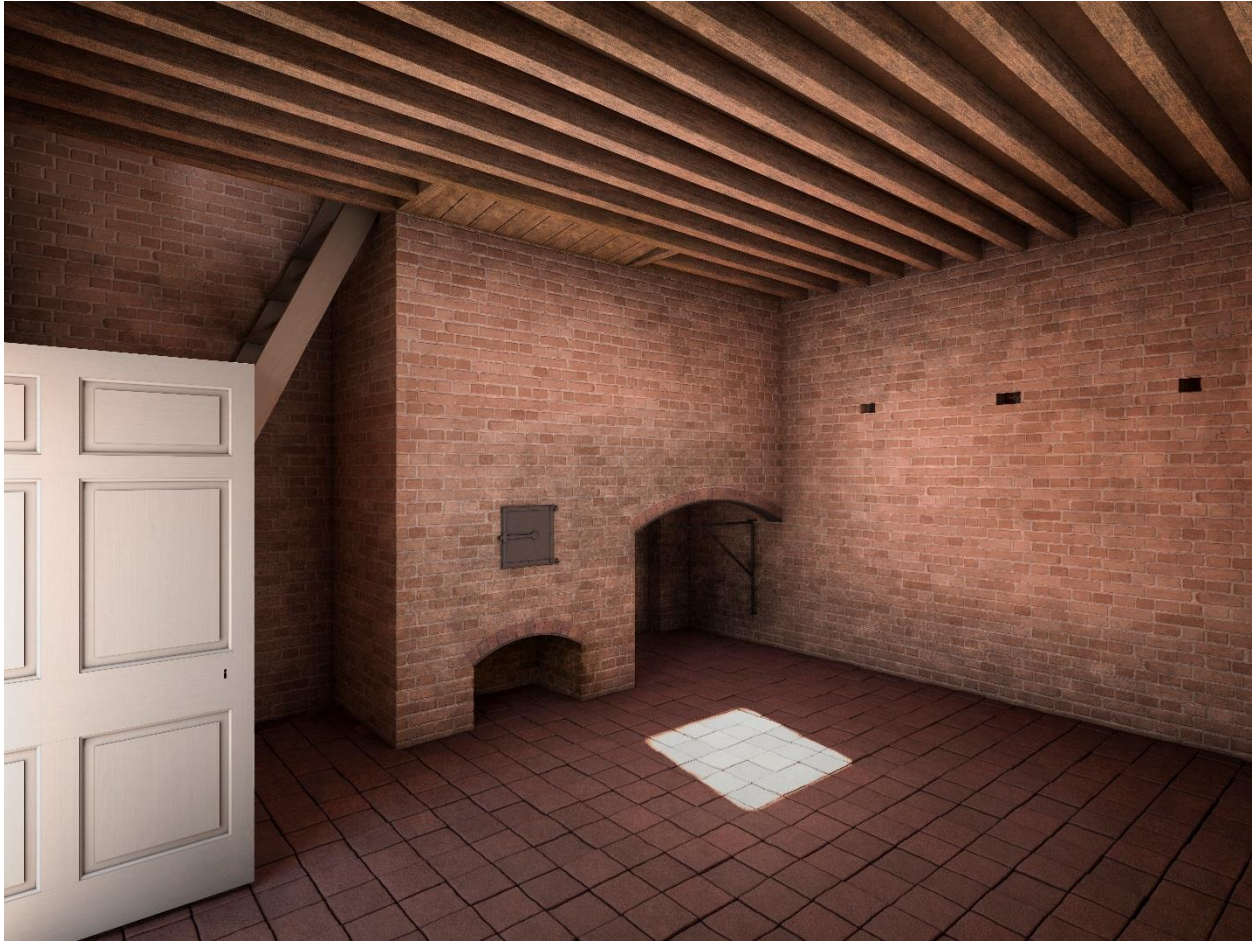
Figure 23: Period 1 South Pavilion interior digital rendering (RenderSphere 2017b). View northwest.

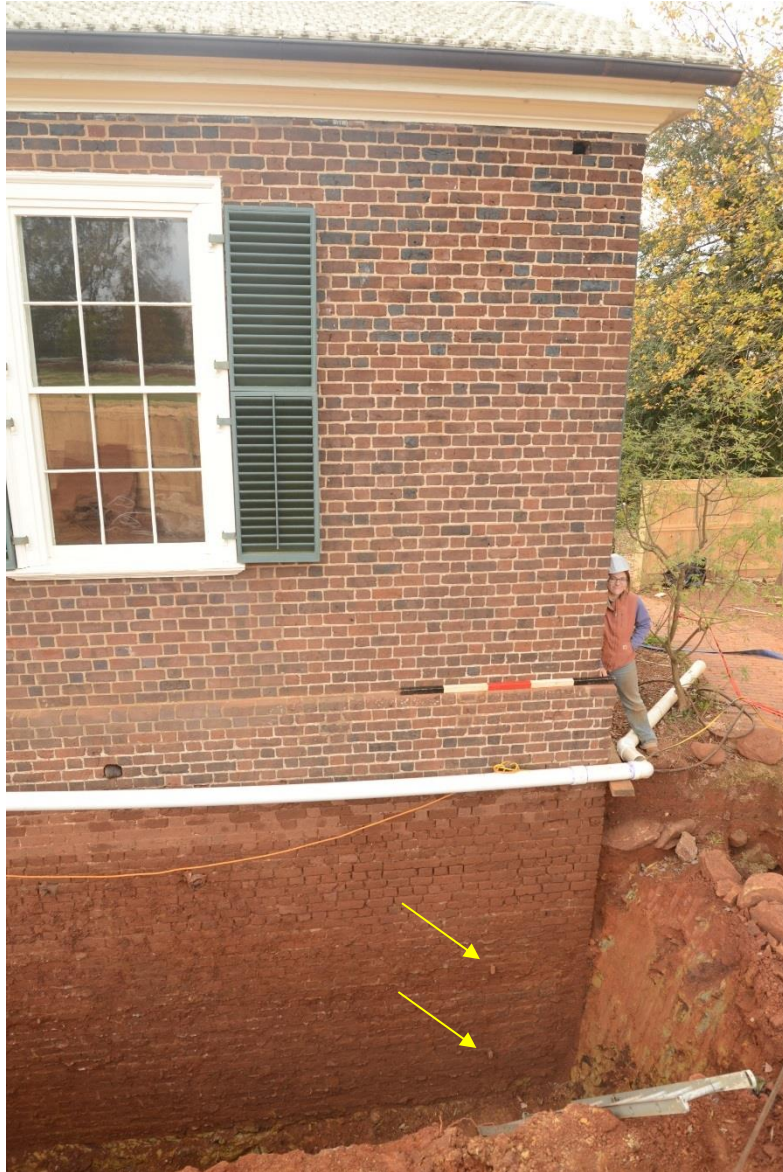
Figure 24: Exterior view of the South Pavilion. Yellow arrows point to the location of the gudgeons found in the West Lawn Drainage project. View south.

Archaeologists first observed the gudgeons on the interior and later at the base of mechanical excavations on the exterior as part of the West Lawn Drainage Project (Figure 24, Figure 25).

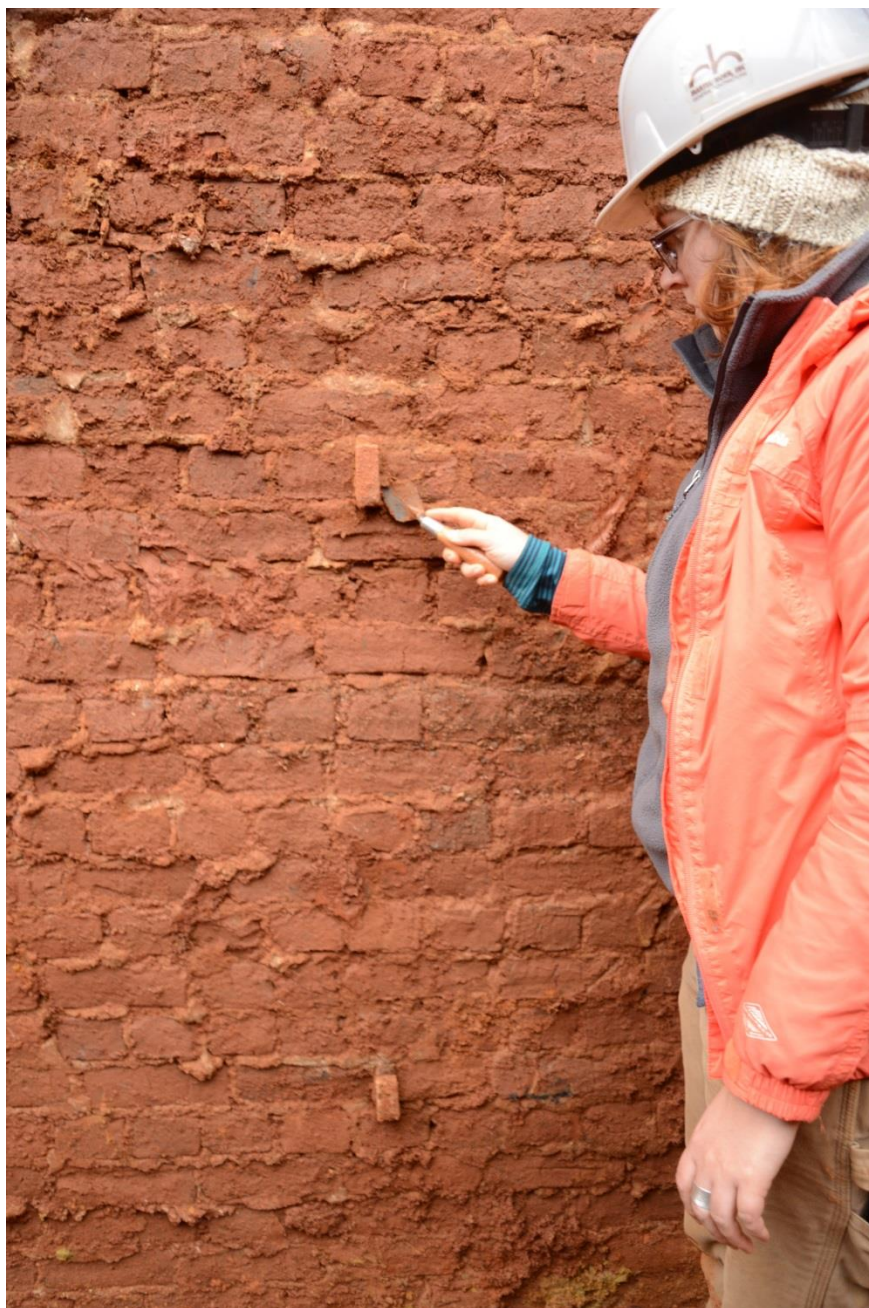
Figure 25: Gudgeons discovered on the exterior of the Pavilion during the West Lawn Drainage Project. View south. These gudgeons were built into the north wall of the Pavilion during the building's original construction.

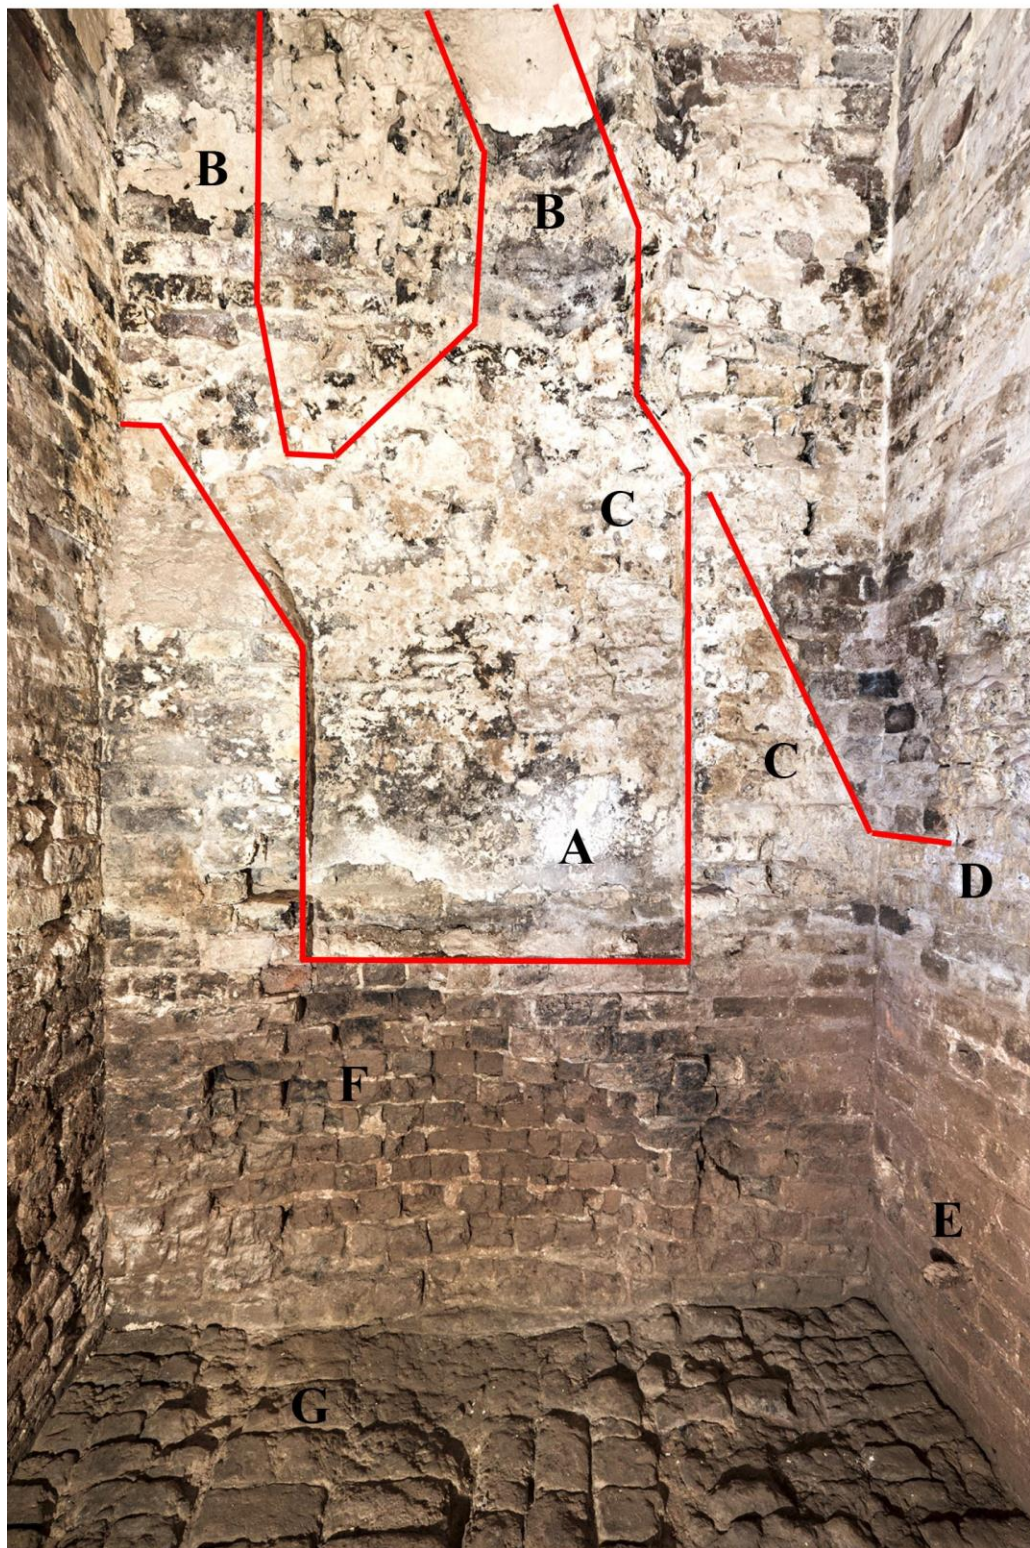
Figure 26: Annotated photo of chimney evidence, west wall (MCWB 2017:30). A is the smoke channel, B notes the flues, C is the throat. On the north wall, D is the spring of the arch, E is the gudgion, F is the back of the fireplace, and G is the hearth. View west.

The top gudgeon, located 3.75' above the interior floor, was broken, but the lower gudgeon, located 0.9' above the floor, was complete.¹⁴ The gudgeons were located inside of the original fireplace (Figure 26).

Angled brick shows where the arch of the fireplace rested against the north wall. Bricks in the Pavilion's west wall, at the back of the original fireplace, were eroded by heat spalling a cavity and covered with ash and charcoal. Above the cavity, a smoke channel was visible in the west wall, as were two flues and the throat of the fireplace.

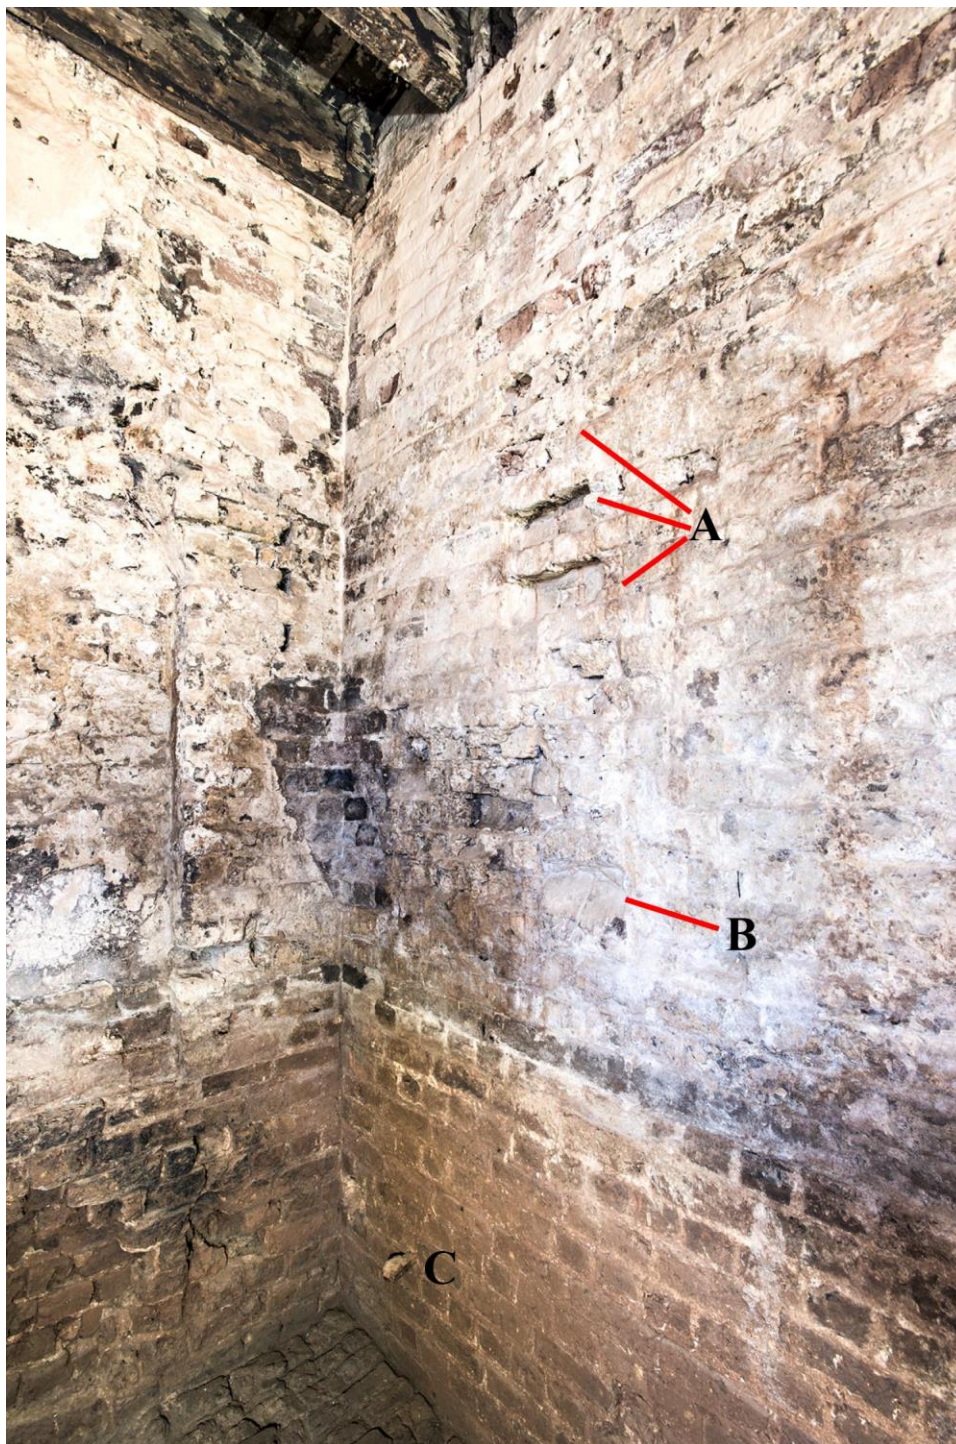
Figure 27: Annotated photo of chimney evidence, north wall. A is racking, B is the spring of the arch, and C is the complete gudgeon. View northwest.

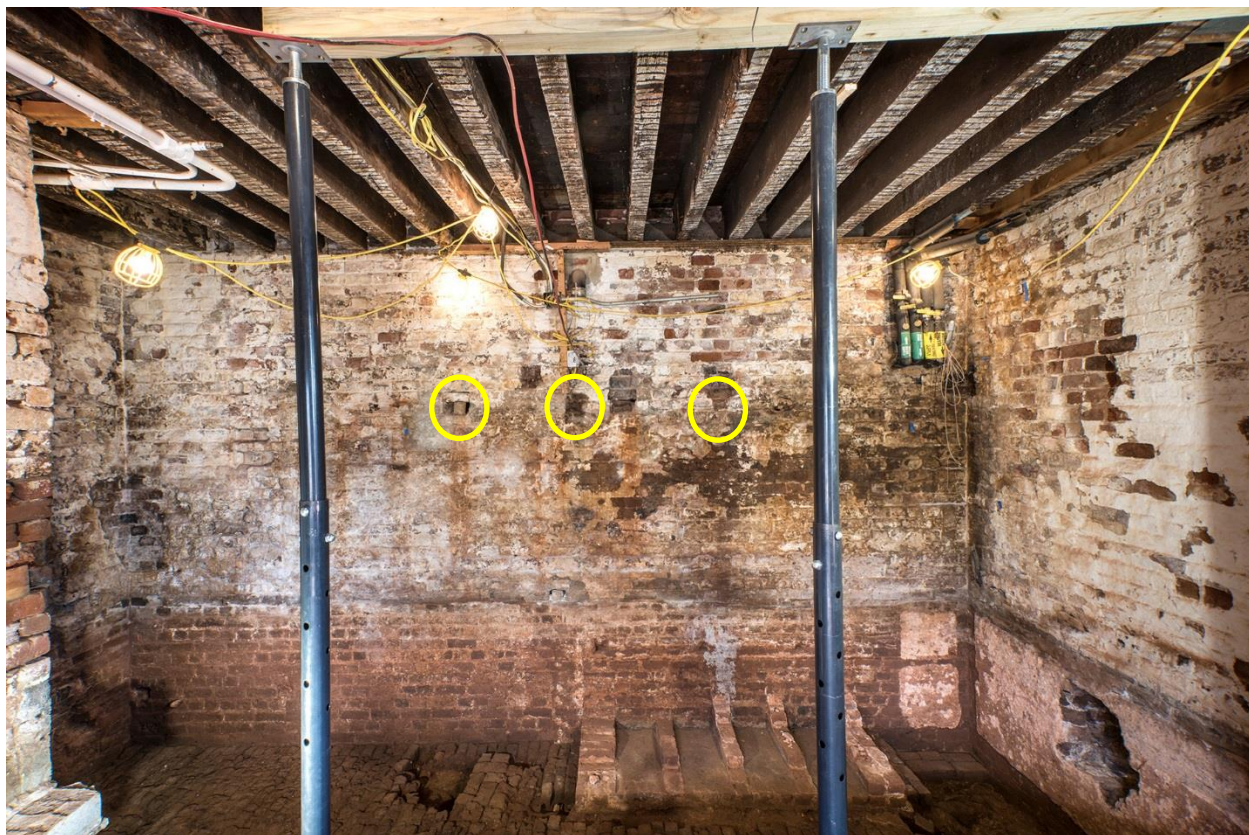
Figure 28: Three holes located along the north wall are circled. These may have been ventilation holes for an early, unrealized set of stew stoves. View north.

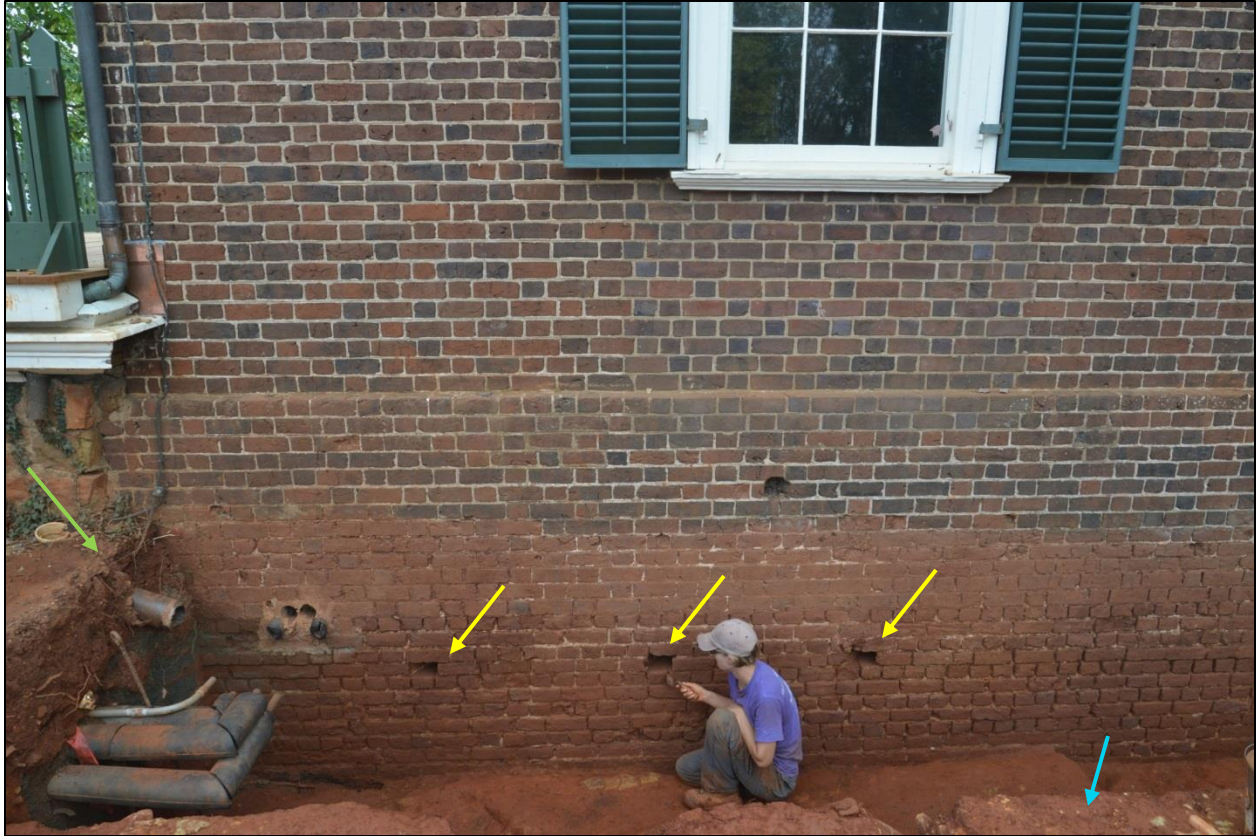
Figure 30: Exterior view of the South Pavilion. Three holes open to the moat and are marked by the yellow arrows. View south. Edge of the moat is indicated by the blue arrow. Ground surface noted on the left by the green arrow.

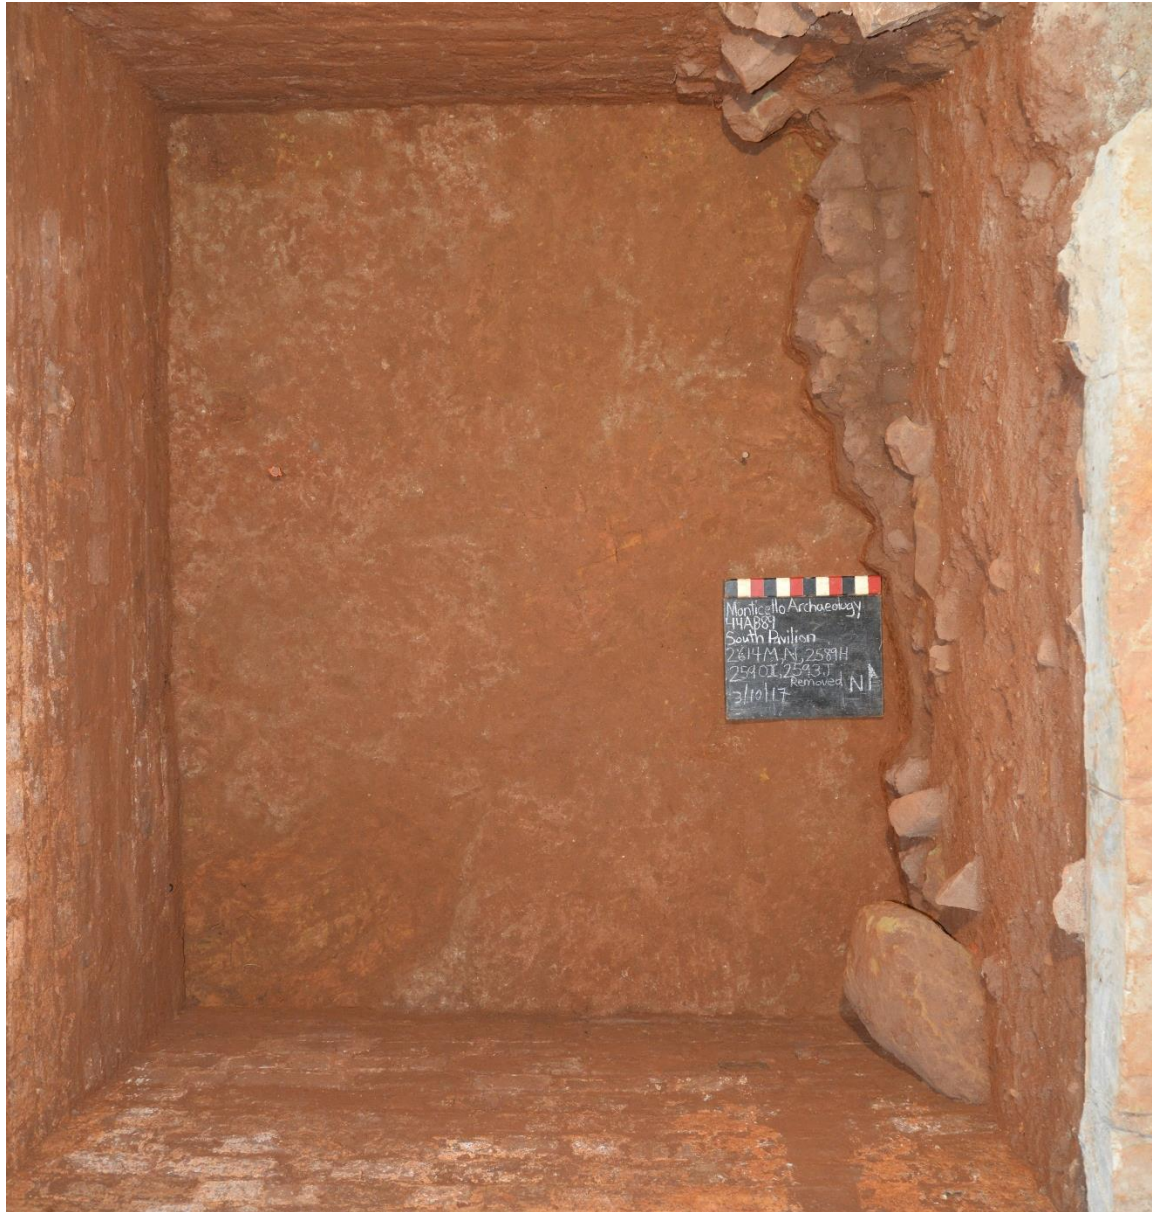
Figure 31: 2614M, 2589H, 2590I, and 2593J closed. View north. Note the remaining brick pavers along the east profile. These square pavers had been chopped into. Their trajectory seems swerve from northwest to southeast to avoid an extant staircase.

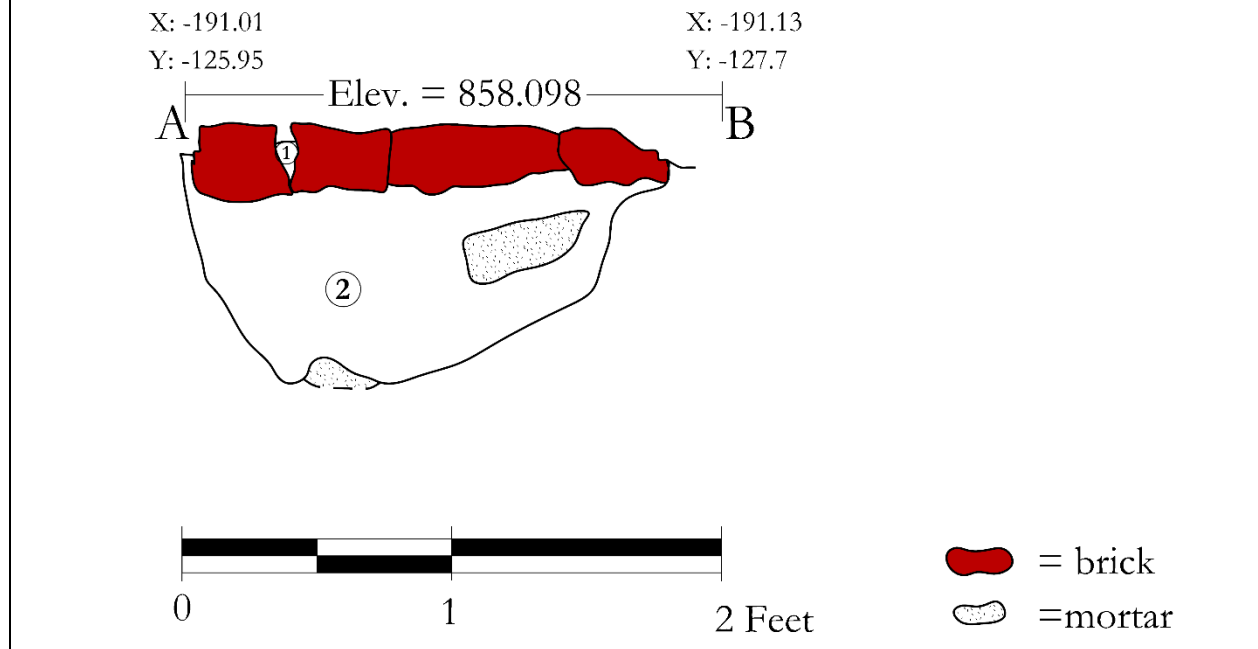
Quadrat 2582, Feature 10 East Profile D-2582-04

Figure 35: D-2582-04, Feature 10 east profile

patch for missing brick. Archaeologists bisected the feature and only removed the western half due to time constraints. Figure 35 and Figure 36 show the eastern and northern profiles (also see Table 3 and Table 4). The pit had an irregular base and bottomed out on bedrock. We hypothesize that the pit connected to the linear ditch (F11), suggesting the pit was a sump to help mitigate flooding. Alternatively, the pit may be the result of builders removing a large piece of bedrock during construction of the Pavilion, and the resulting fill may have settled unevenly, which meant the hole needed more fill. We considered the hypothesis that the pit could have been a subfloor pit or the base of a set kettle, but with an irregular bottom and without any evidence for a fire, these options seem unlikely.

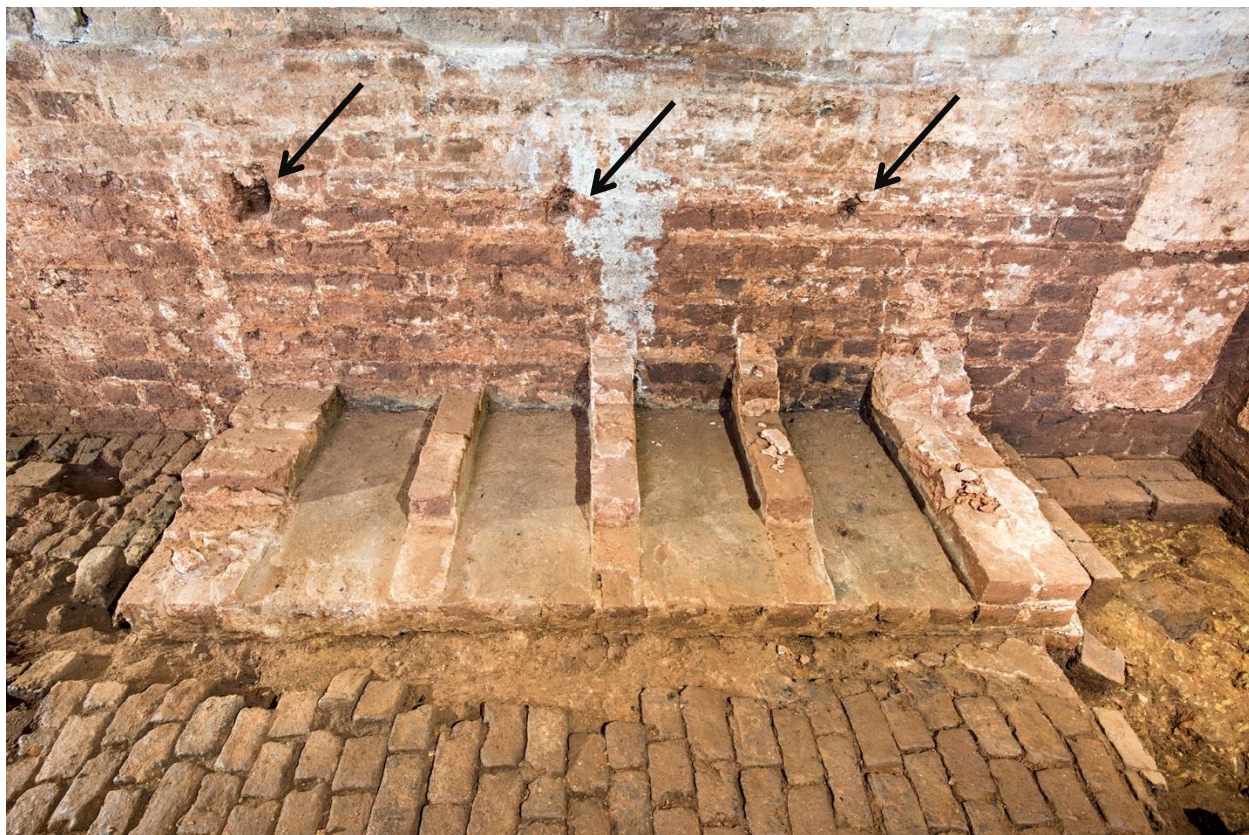
Figure 37: Stew stove from Period 3. View north. The arrows point to evidence for the presence of an earlier Period 2 stew stove. Note the three holes above the current stoves (black arrows).

Jefferson's first stew stove was apparently installed during this period, as well. This first stove left no masonry remains. However, we highlight two lines of evidence for its existence. First, three small notches cut into the northern wall less than two feet above the surviving stew stove foundation (Figure 37, Figure 38). These holes do not align with the architecture of the

surviving brick foundation of what we believe was the second stew stove installed in the kitchen. We therefore suspect that they were hacked into the wall to key the masonry for an earlier stove into the wall. The second line of evidence is the linear drainage ditch, Feature 11. Its northern edge did not lie against the north wall of the kitchen, but roughly 1.5 feet south of it (Figure 42). Why did the ditch installers leave a 1.5-foot swath of brick floor against the north wall in place? By placing the ditch flush against the wall, they would have minimized chances that people stumbled into it. A compelling hypothesis is that the northern edge of the ditch lay against an existing piece of equipment or architectural element that extended 1.5 feet out from the wall. An earlier stew stove is a likely possibility. From his earliest sketches (N59), Jefferson planned for his kitchen to include a stew stove in this location, so this is a likely spot for an earlier stove. However, this hypothesized earlier stove must postdate the initial construction of the kitchen, since it sat on top of the later brick-on-end floor.
