The Archaeology of Monticello's South Pavilion and South Wing

By
Crystal O'Connor and Fraser Neiman
Monticello Department of Archaeology

Monticello Department of Archaeology Technical Report Series Number 7

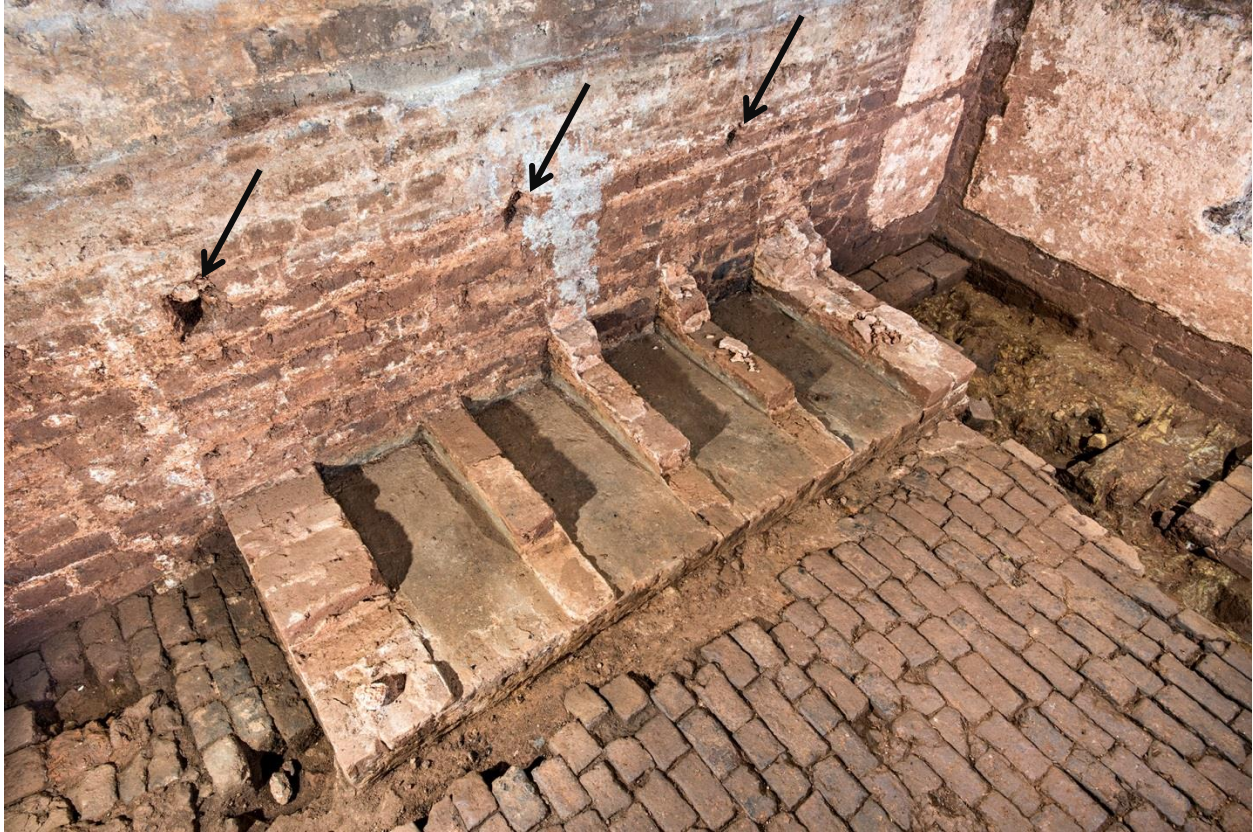
Figure 38: Stew stove from Period 3. View northeast. The arrows point to evidence for the presence of an earlier Period 2 stew stove. Note the three holes above the current stoves (black arrows).

Jefferson's first stew stove was apparently installed during this period, as well. This first stove left no masonry remains. However, we highlight two lines of evidence for its existence. First, three small notches cut into the northern wall less than two feet above the surviving stew stove foundation (Figure 37, Figure 38). These holes do not align with the architecture of the

surviving brick foundation of what we believe was the second stew stove installed in the kitchen. We therefore suspect that they were hacked into the wall to key the masonry for an earlier stove into the wall. The second line of evidence is the linear drainage ditch, Feature 11. Its northern edge did not lie against the north wall of the kitchen, but roughly 1.5 feet south of it (Figure 42). Why did the ditch installers leave a 1.5-foot swath of brick floor against the north wall in place? By placing the ditch flush against the wall, they would have minimized chances that people stumbled into it. A compelling hypothesis is that the northern edge of the ditch lay against an existing piece of equipment or architectural element that extended 1.5 feet out from the wall. An earlier stew stove is a likely possibility. From his earliest sketches (N59), Jefferson planned for his kitchen to include a stew stove in this location, so this is a likely spot for an earlier stove. However, this hypothesized earlier stove must postdate the initial construction of the kitchen, since it sat on top of the later brick-on-end floor.

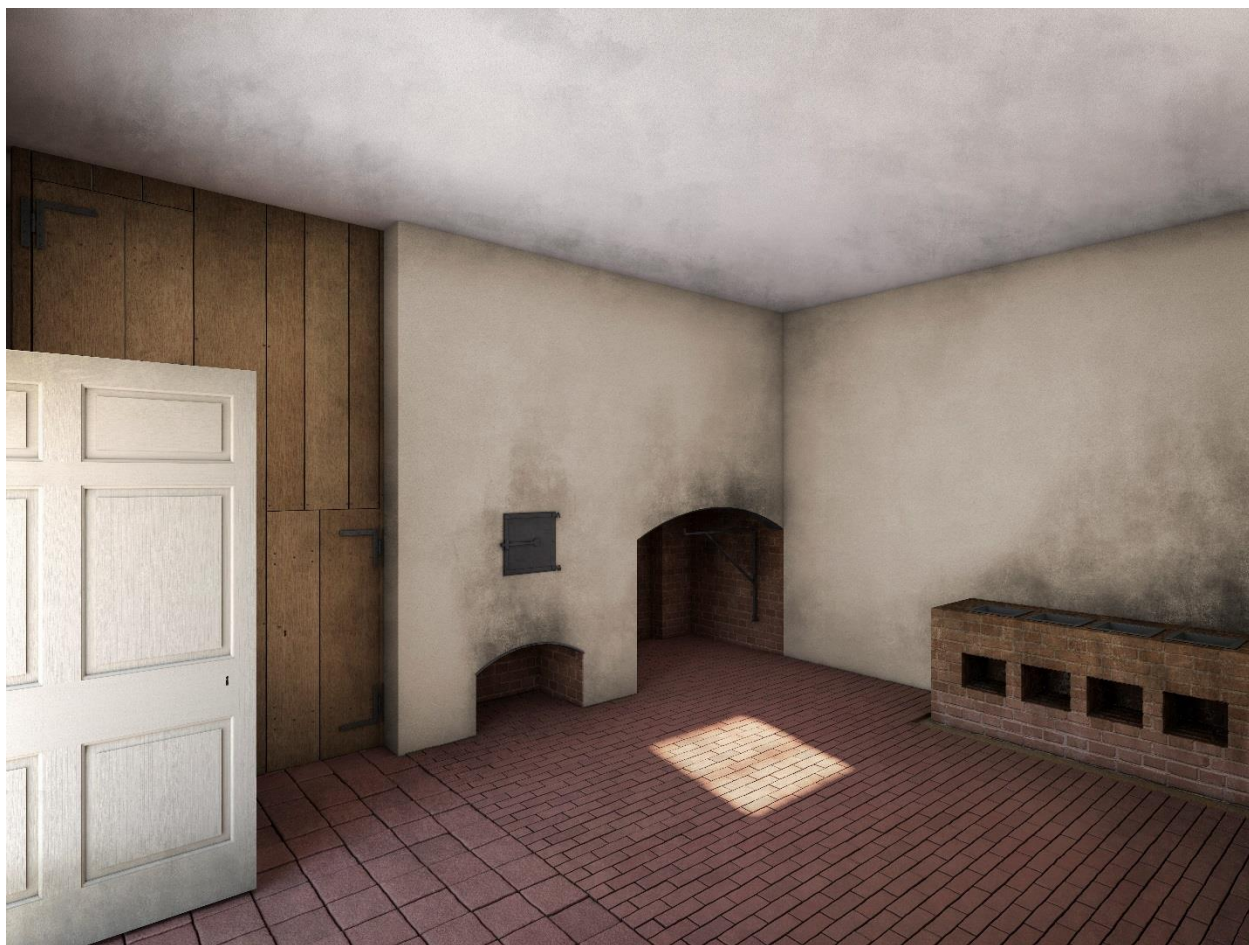
Figure 39: Period 3 kitchen digital rendering (RenderSphere 2017c). View northwest.

Architectural changes to the kitchen that date to Period 3 may coincide with the return of Jefferson from a diplomatic appointment in France in 1789 and soon thereafter the beginning of the construction and landscaping campaign that resulted in Monticello II. The South Pavilion kitchen saw a number of important upgrades including the replacement of the dresser and the application of plaster to the walls adjacent to it (Figure 39). Along the north wall of the Pavilion,

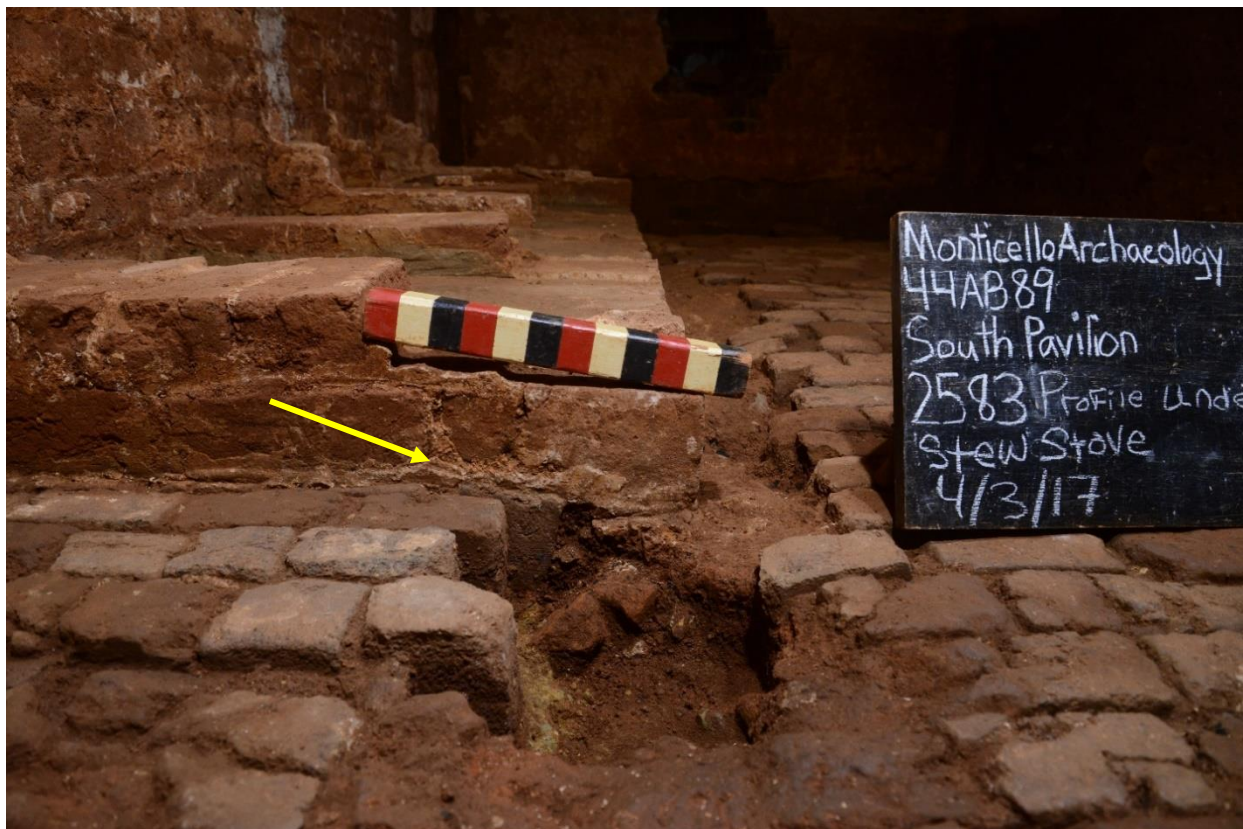
Figure 40: Profile of stew stove in 2583. View east. Note the yellow arrow pointing to the mortar layer between the brick floor and the stew stove. Masons applied this mortar top of the brick floor to provide a base on which the stew stove rested.

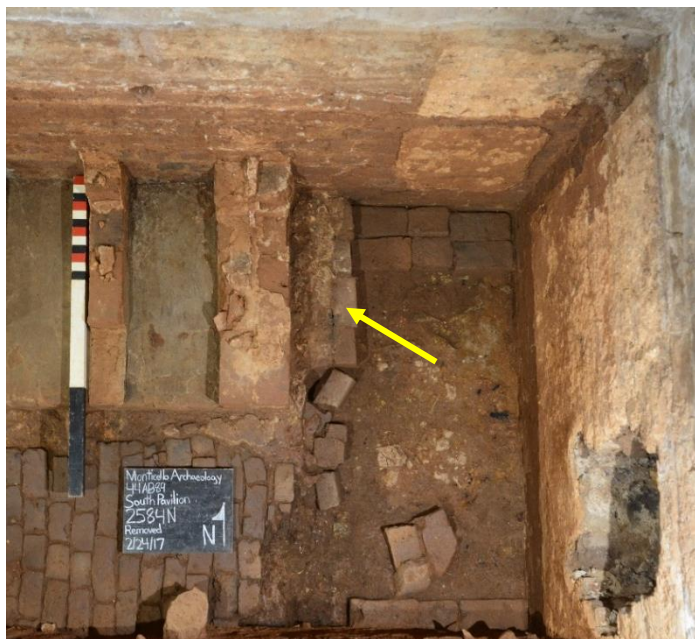
Figure 41: East half of stew stove. View north. Note the yellow arrow pointing to the mortar layer between the brick floor and stew stove. Masons applied this mortar top of the brick floor to provide a base on which the stew stove rested.

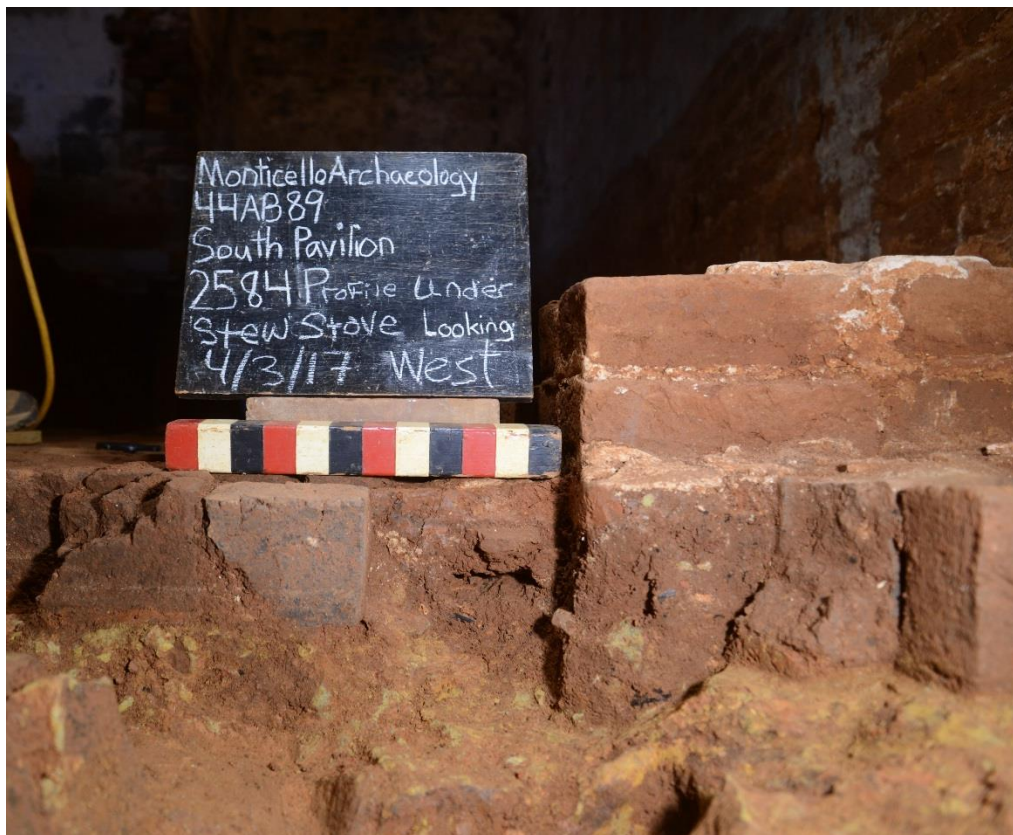
Figure 43: Profile of Feature 11 under the stew stove in 2584. View west. See Figure 42 for measured drawing.

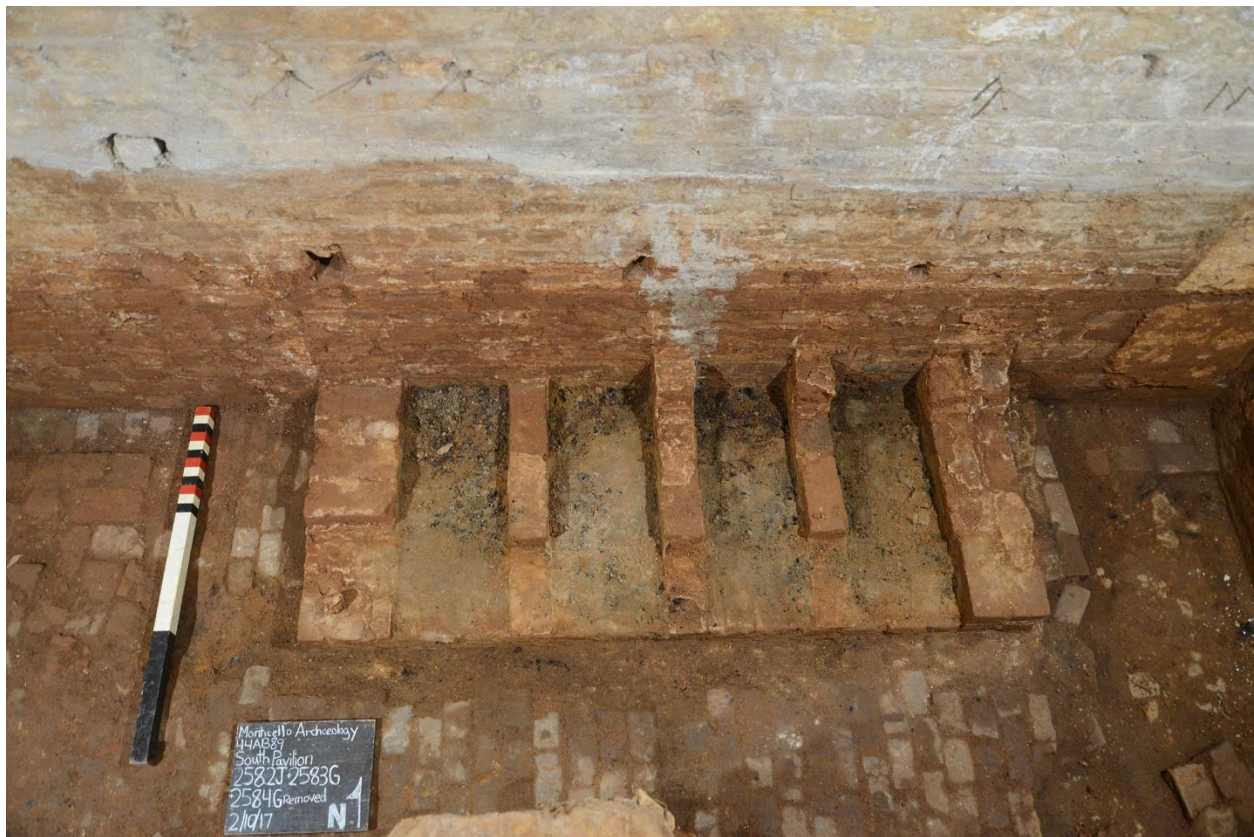
Figure 45: Stew stove (F12). 2582J, 2583G, 2584G removed. View north.

The stove (F12) was 5.9 by 2.1 feet in plan (Figure 20, Figure 45). The remains included four compartments, each 0.9 feet wide. The divisions between the compartments are comprised of one row of brick stretchers. The eastern leg is built with two rows of brick stretchers laid side by side while the western leg is built with one row of headers. Each leg measures 0.7 feet wide, and each interior compartment division is 0.3 feet wide (the width of one brick). The bottoms of the compartments were covered with a smooth coat of plaster, presumably to facilitate cleaning ash from them. Ash and charcoal (SG17/F12) lay in each compartment. Archaeologists collected samples from each of the compartments for pollen analysis and wood identification.

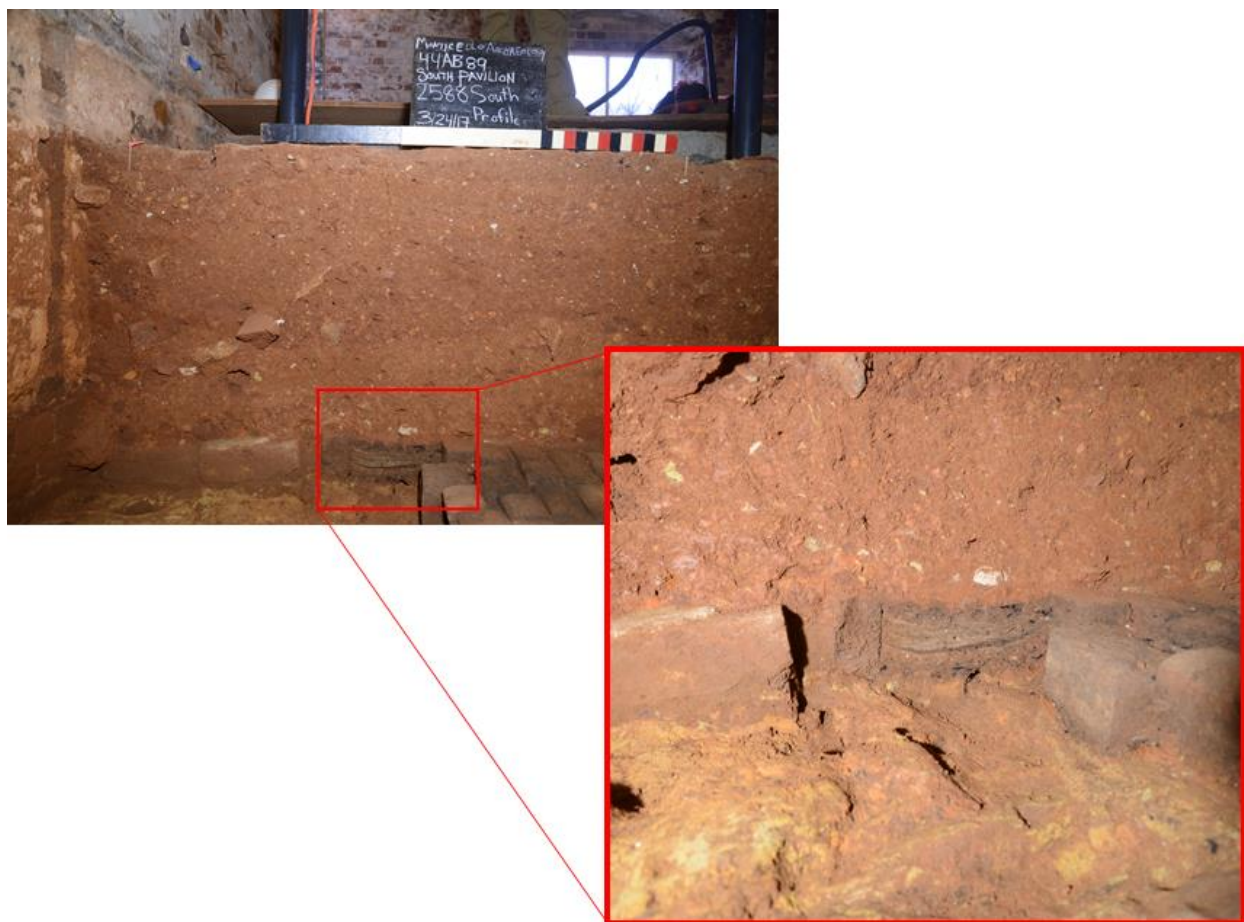
Figure 48: 2588 south profile. The laminated layers from Feature 11 discussed above are shown in the inset.

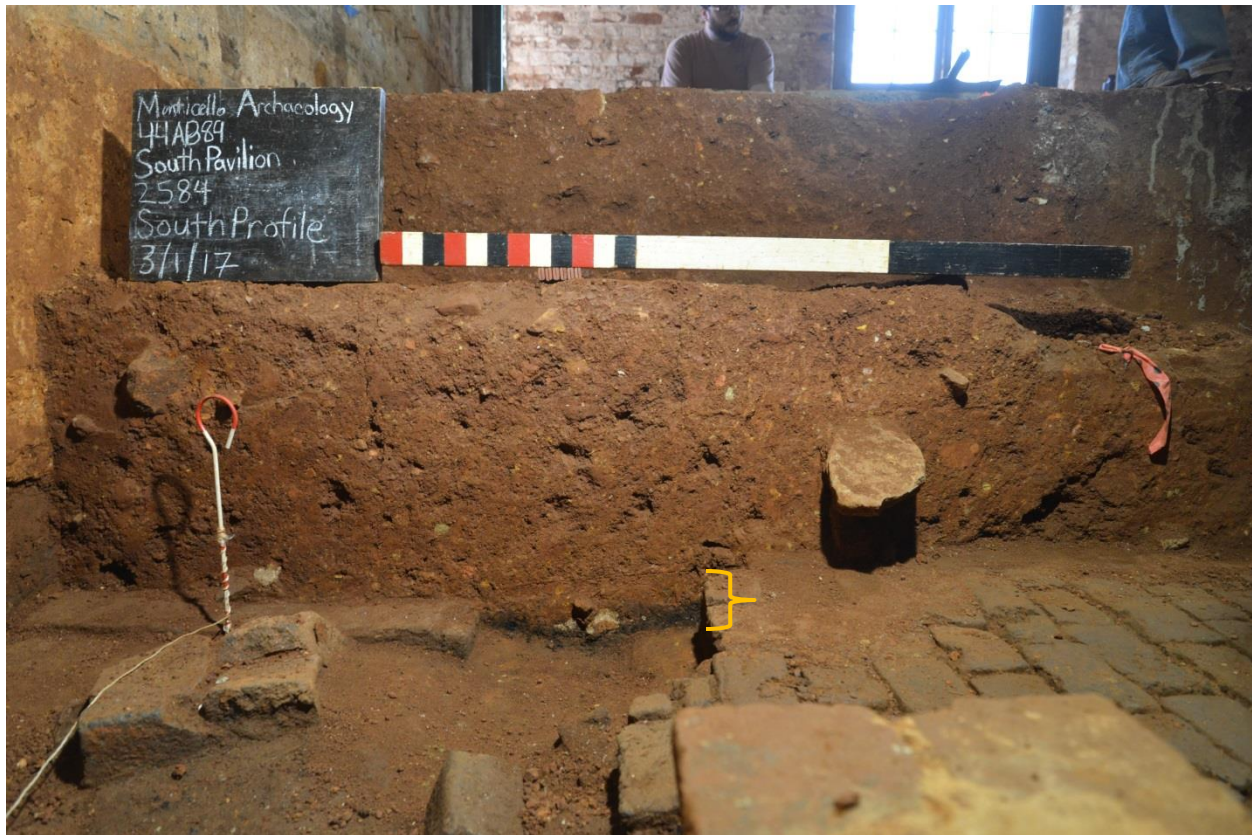
Figure 49: 2584 south profile. The laminated layers from Feature 11 discussed above are indicated by the orange bracket. Note the fewer layers in the profile from 2584 compared with that from 2588. No closeup was taken of the laminated layers in this quadrat.

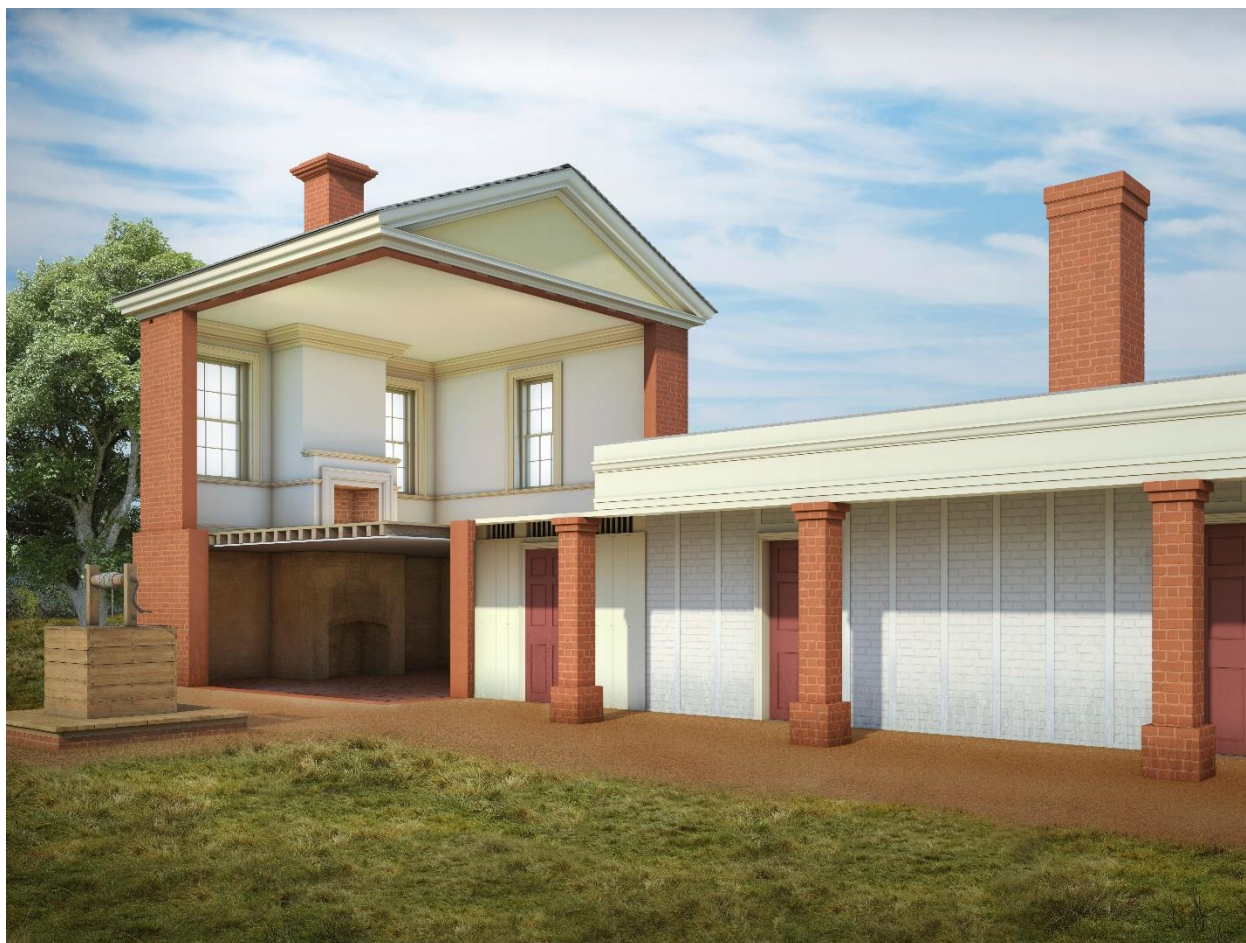
Figure 50: Period 4 South Pavilion, including a Wash House in the basement, and Wing, digital rendering (RenderSphere 2017d). View northwest.

Final changes to the South Pavilion during this last period started the year before Jefferson's retirement from the presidency and from public life. To complete his vision for the landscape, Jefferson had the kitchen moved to the eastern-most room in the newly constructed South Wing and had the South Pavilion kitchen filled with three feet of dirt to match the level of the Wing. He altered the function of the Pavilion from a kitchen to a Wash House (Figure 50). Stratigraphic groups from Period 4 can be seen in Table 9.

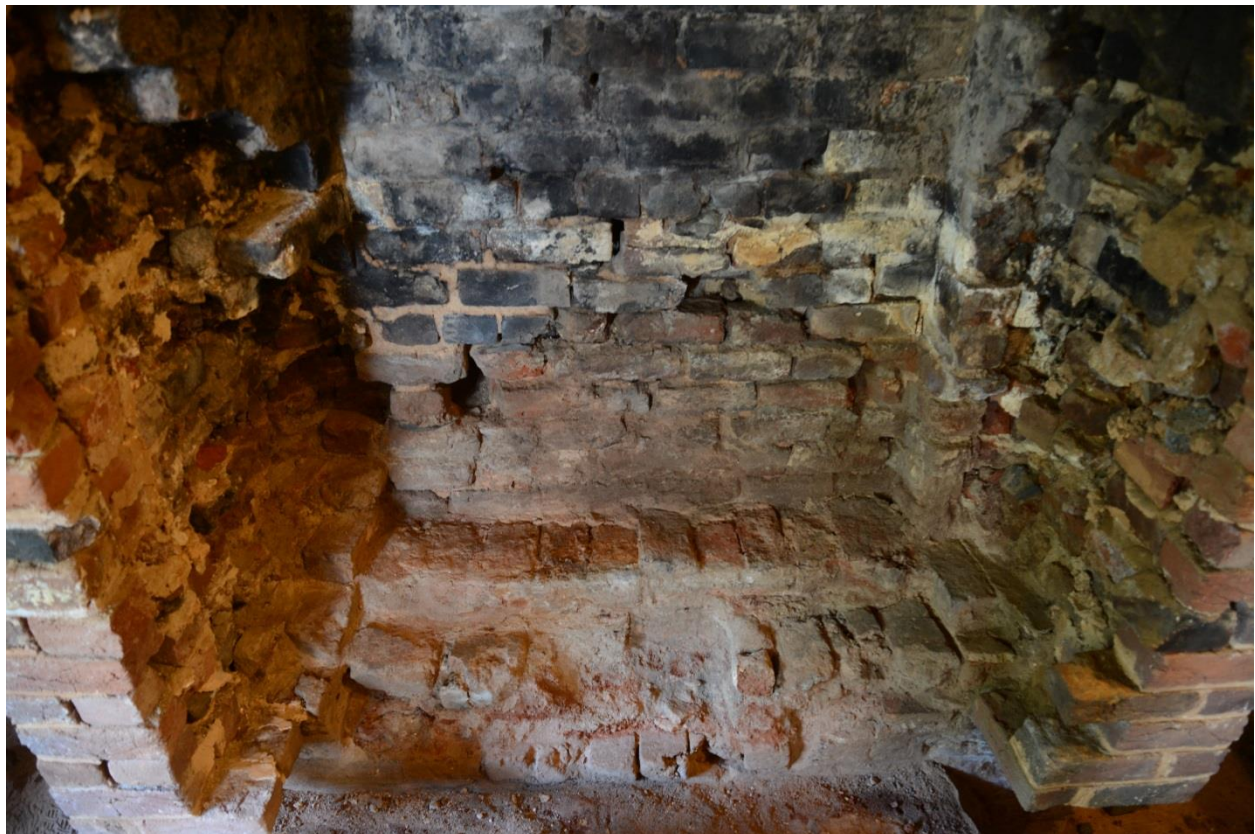
Figure 53: Interior of the central fireplace post-excavation. View west.

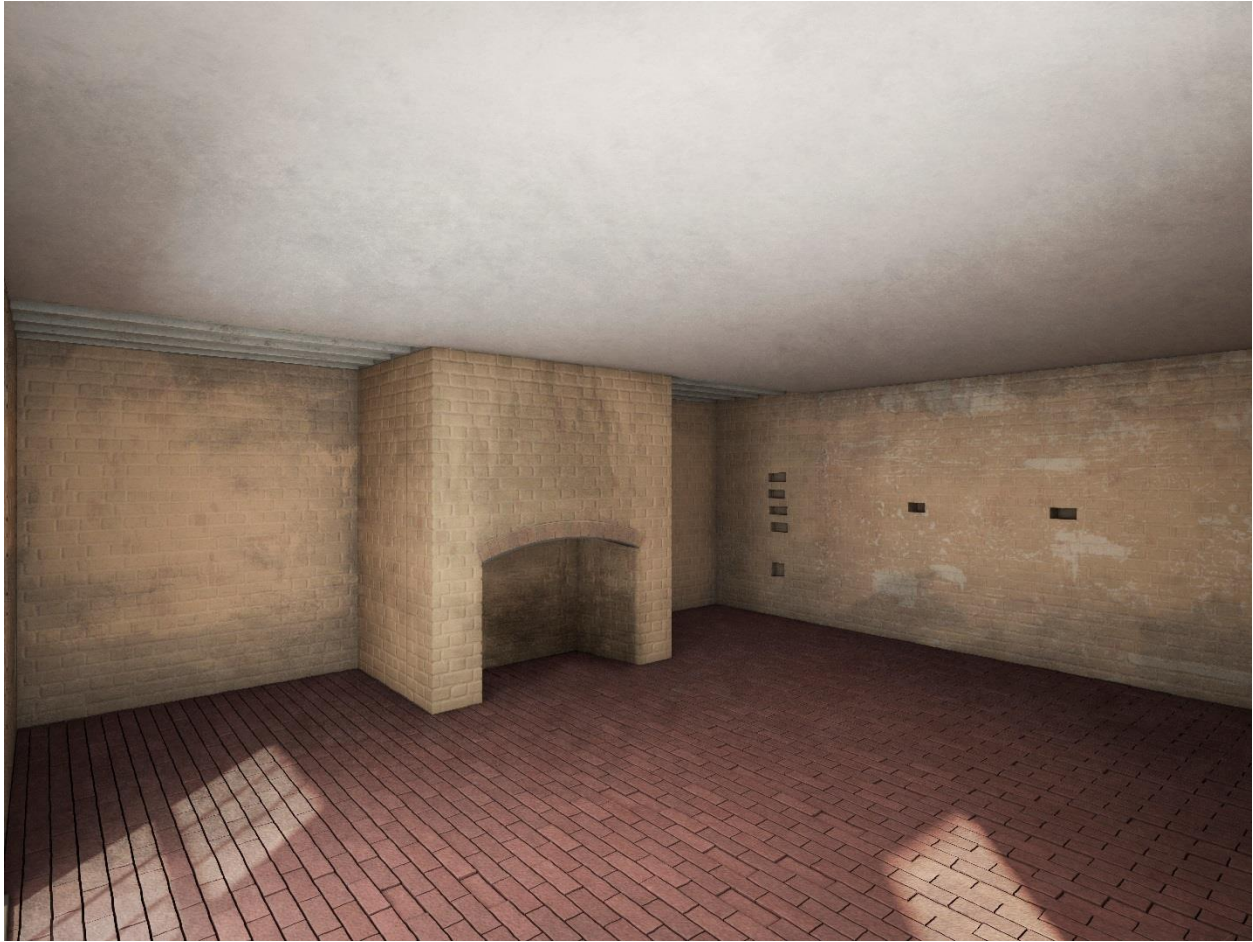
Figure 54: South Pavilion as a Wash House digital rendering (RenderSphere 2017e). View northwest.

Stratigraphic groups and features from Period 5 can be seen in Table 12. During contractor Henry Kersley's stabilization of the Wash House fireplace, he removed cinder block and brick repairs dating to Grigg's 1941 restoration. On the fireplace's floor, archaeologists noted a pocket of hardened ash (SG29 in F17, Figure 51). Archaeologists bisected this deposit (Figure 52, Table 10). It was composed of ash and degrading, burned brick and mortar (Figure 53). This is an ash deposit from use of the fireplace in the 19th and early 20th centuries (Figure 54). Excavations stopped here once brick masonry was reached.

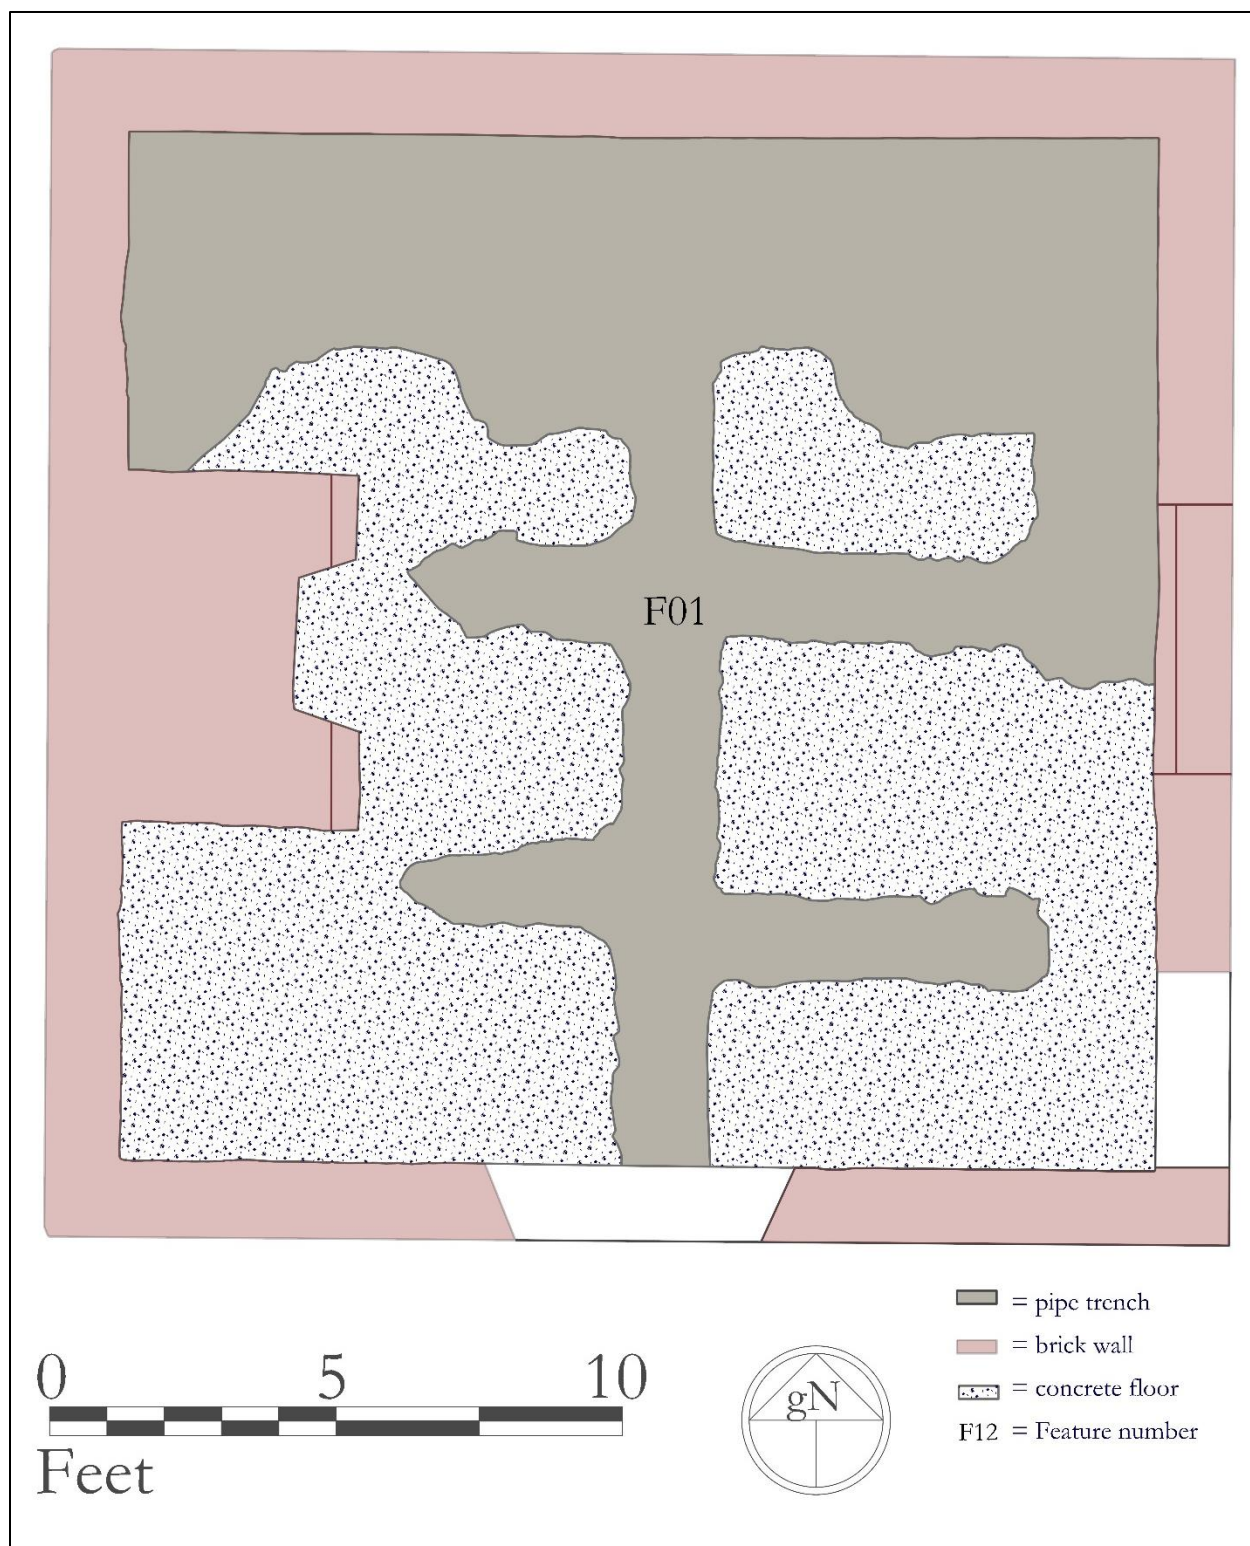
Figure 55: South Pavilion with 20th-century pipe trenches (F01)

Before the archaeological investigation of the South Pavilion began, a crew from K&L Construction demolished the men's room that had been installed in the Pavilion in 1967. Their work included pulling down the hanging ceiling, removing toilets and urinals, pulling tile of the walls, removing the HVAC unit, and pulling up the tile floor. Below that was a concrete substrate and ceramic structural block underlayment for the brick floor that Milton Grigg had installed in 1941 when the Wash House was initially restored. The bricks had been removed when by the men's room was installed in 1967. Removal of the demolition debris (SG48) revealed intersecting backfilled trenches that had chopped through the concrete and tile subfloor

(Figure 55, Figure 56). These trenches contained cast iron and copper pipes that served the sinks and toilets. Archaeologists excavated the trenches as Feature 1 (SG47). K&L Construction removed additional portions of the concrete floor, which exposed Grigg's excavations.

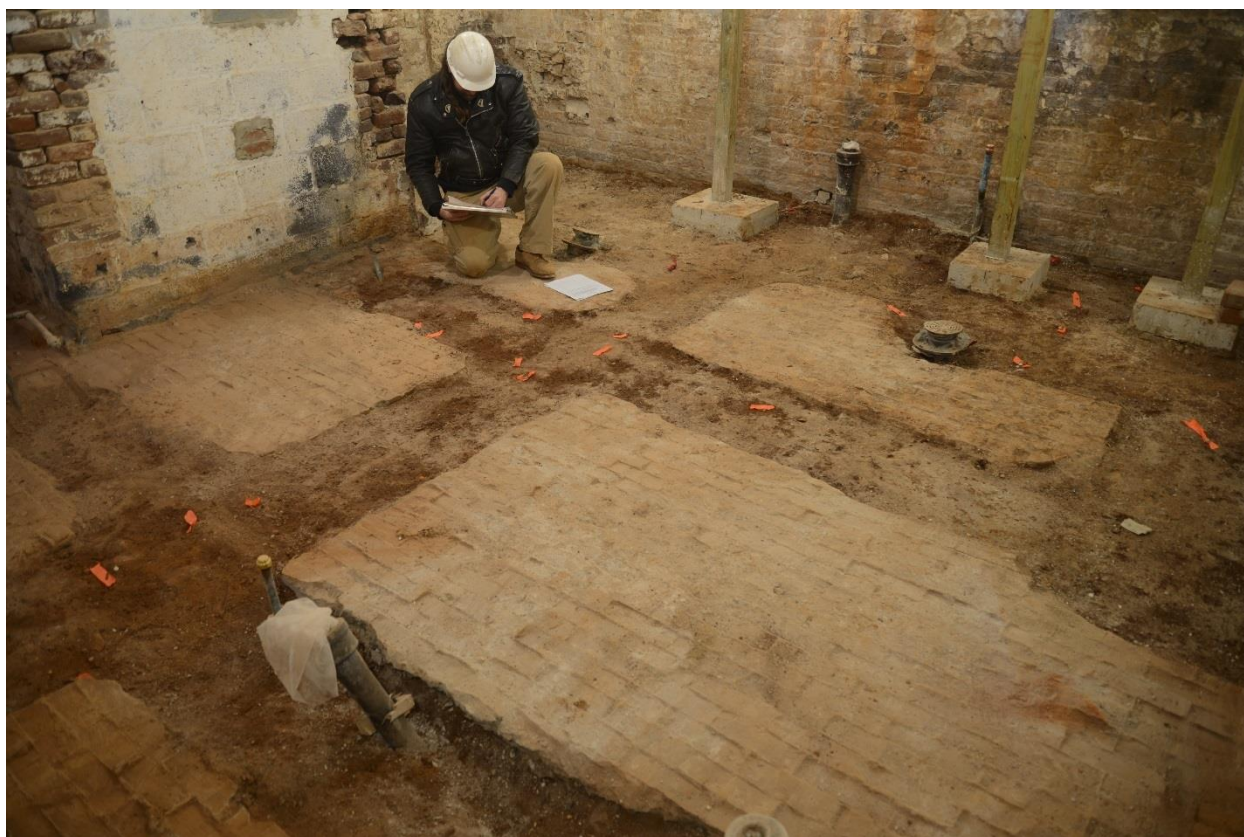
Figure 56: Archaeologist Elliott Jones recording the excavation of SG48. View northwest.

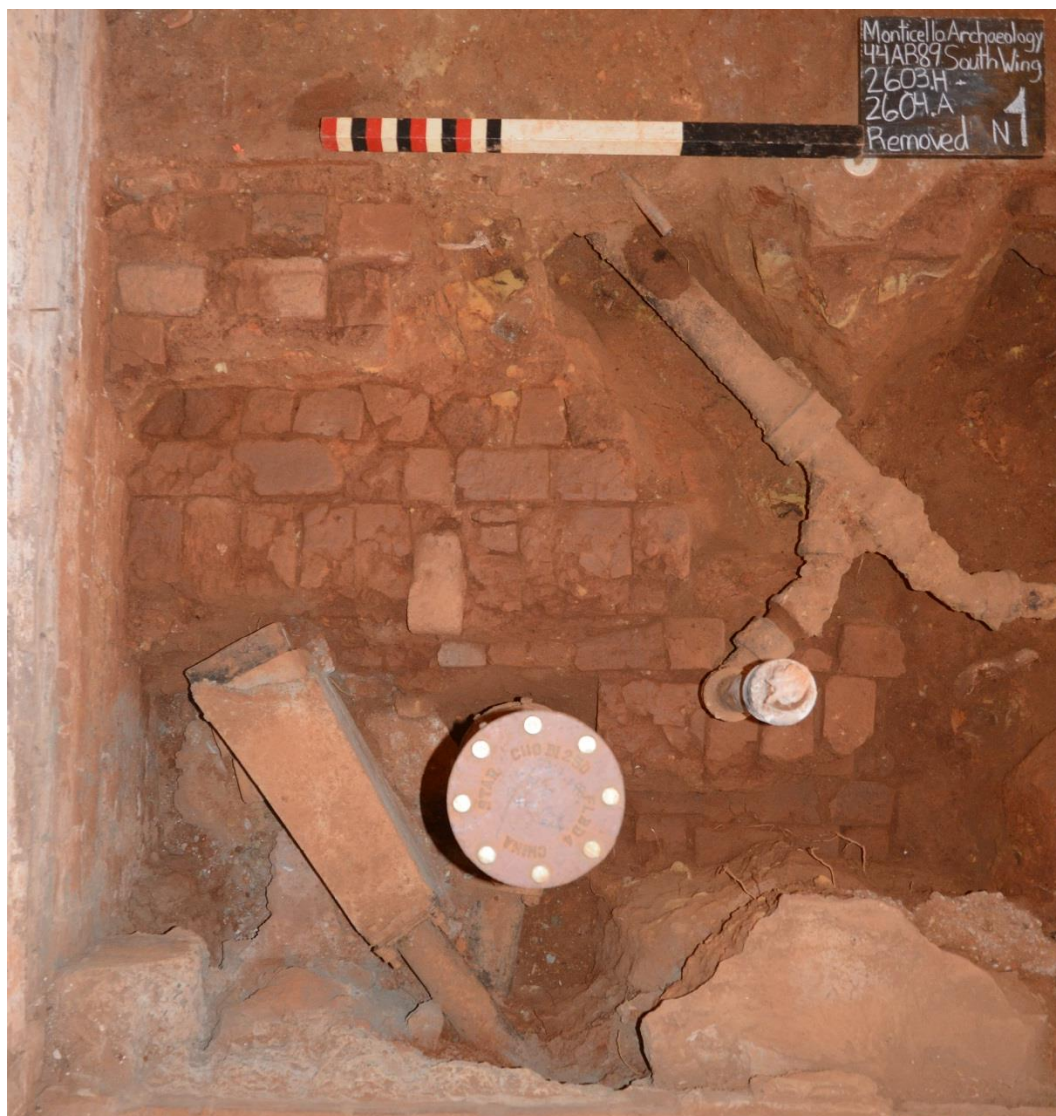
Figure 62: 1770s stairs plan view. 2603H and 2604A removed. View north.

Archaeologists left the stairs *in situ* and covered them with filter fabric. Construction crews placed a concrete footer on top of the bricks to support a new frame wall but first protected the stairs with foam. The new concrete footer cantilevered so as not to rest directly upon the bricks themselves.

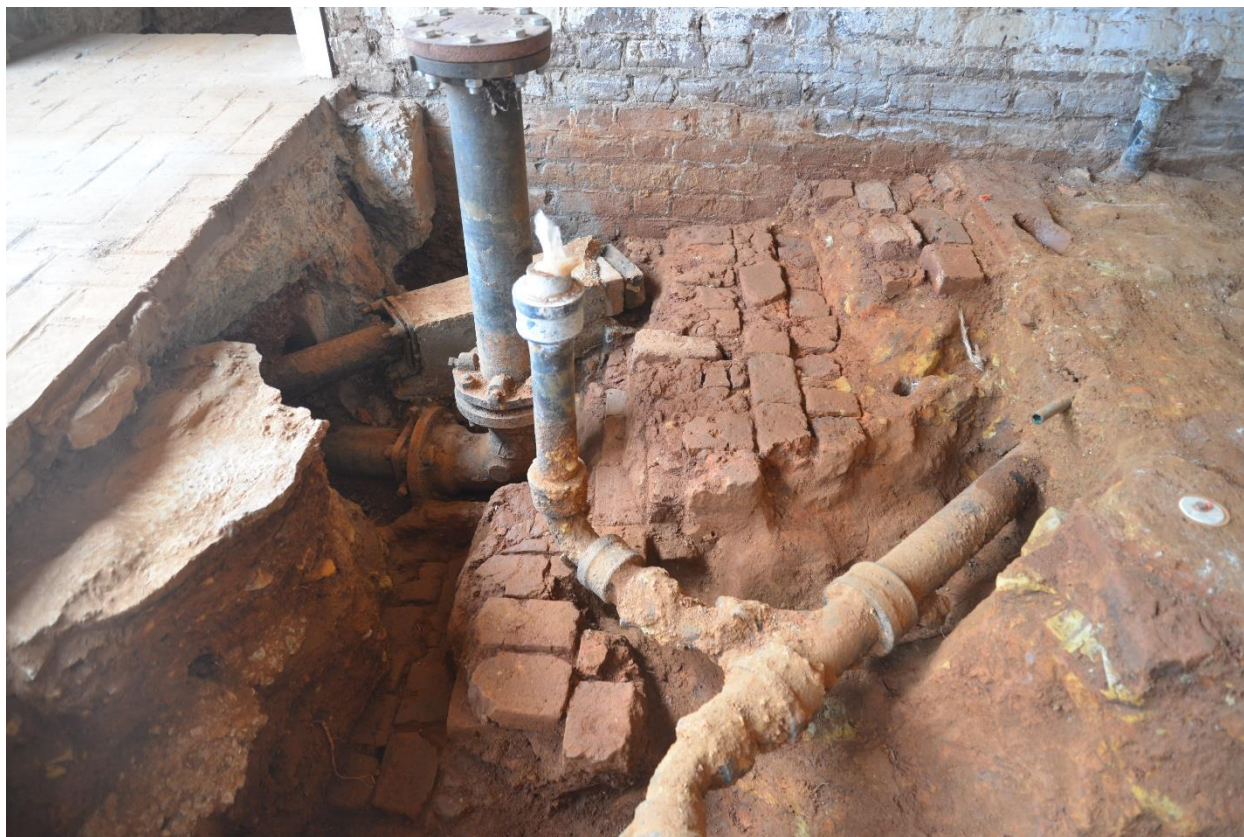
Figure 63: 1770s stairs in profile. View west.

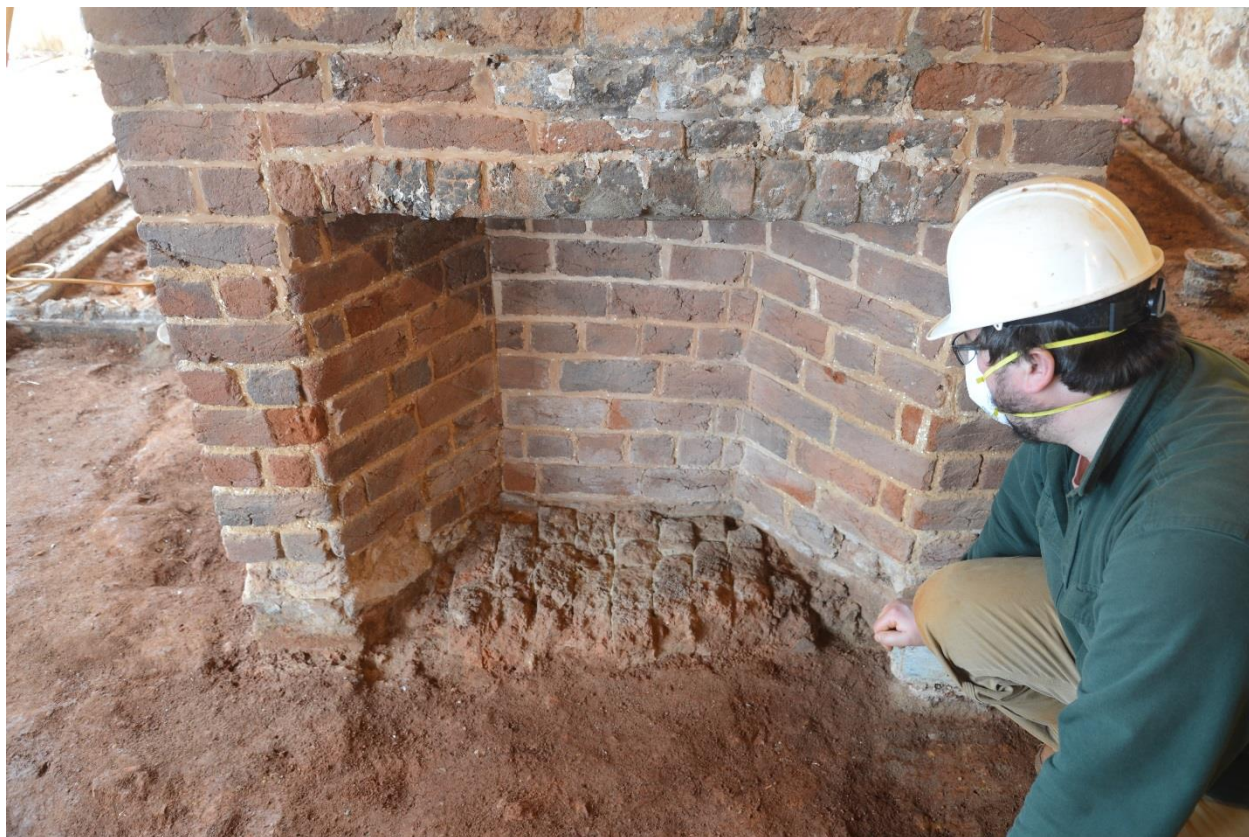
Figure 64: Archaeologist Craig Kelley observes Feature 15, the fireplace hearth in the east "servant's room." View west.

The two rooms for enslaved domestics were heated by back-to-back fireplaces sharing a single stack. Archaeologists cleaned and photographed the hearth (F15) in the east room and left it *in situ* (Figure 64). In the west room, mason Henry Cersley removed cinder blocks installed in the 1940s, photographed the remaining hearth (F17), and stabilized the bricks in the chimney stack (Figure 65). The handmade bricks in both hearths were badly deteriorated. In both cases, the bricks were laid on their sides. They were protected before the new exhibits were installed.

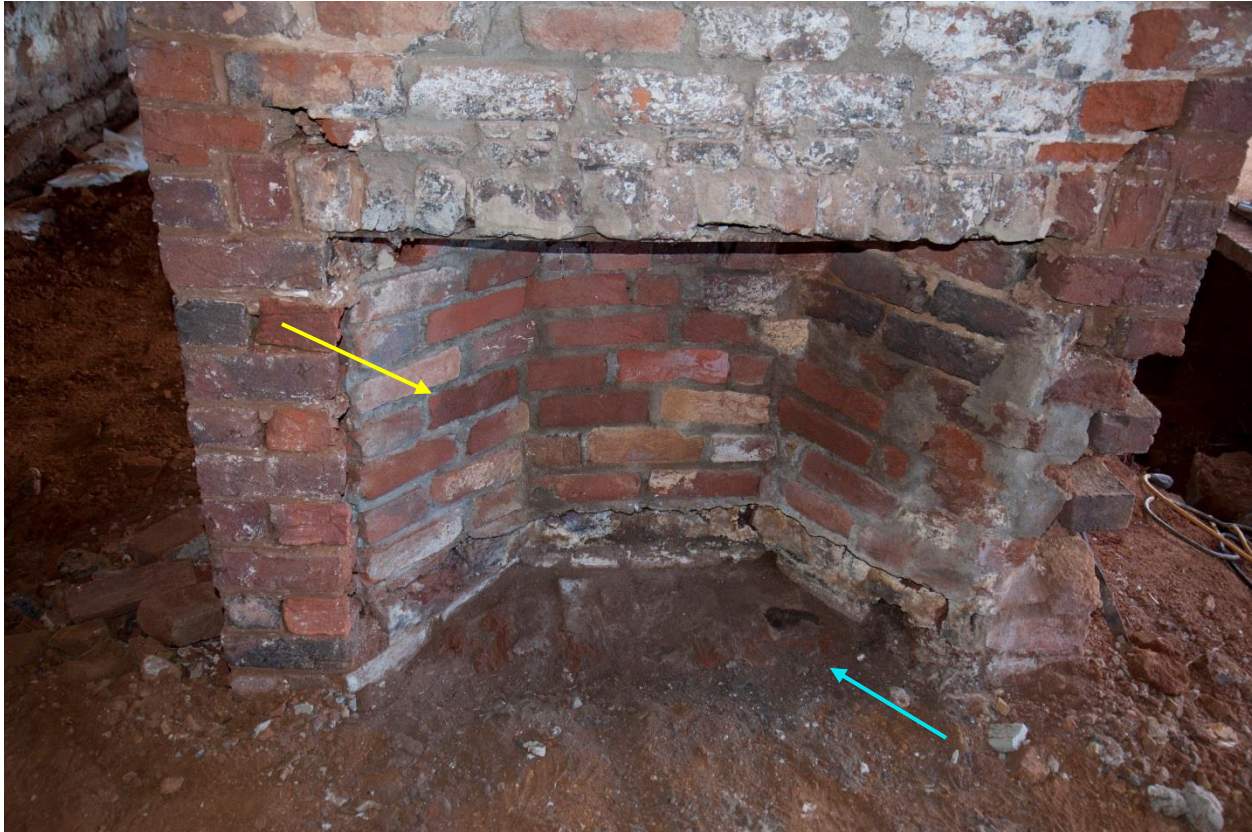
Figure 65: The fireplace hearth (Feature 17) in the west "servant's room." View east. The yellow arrow points to a later repair that then was removed by Henry Cersley in February of 2017. The blue arrow points to what is left of the original hearth.

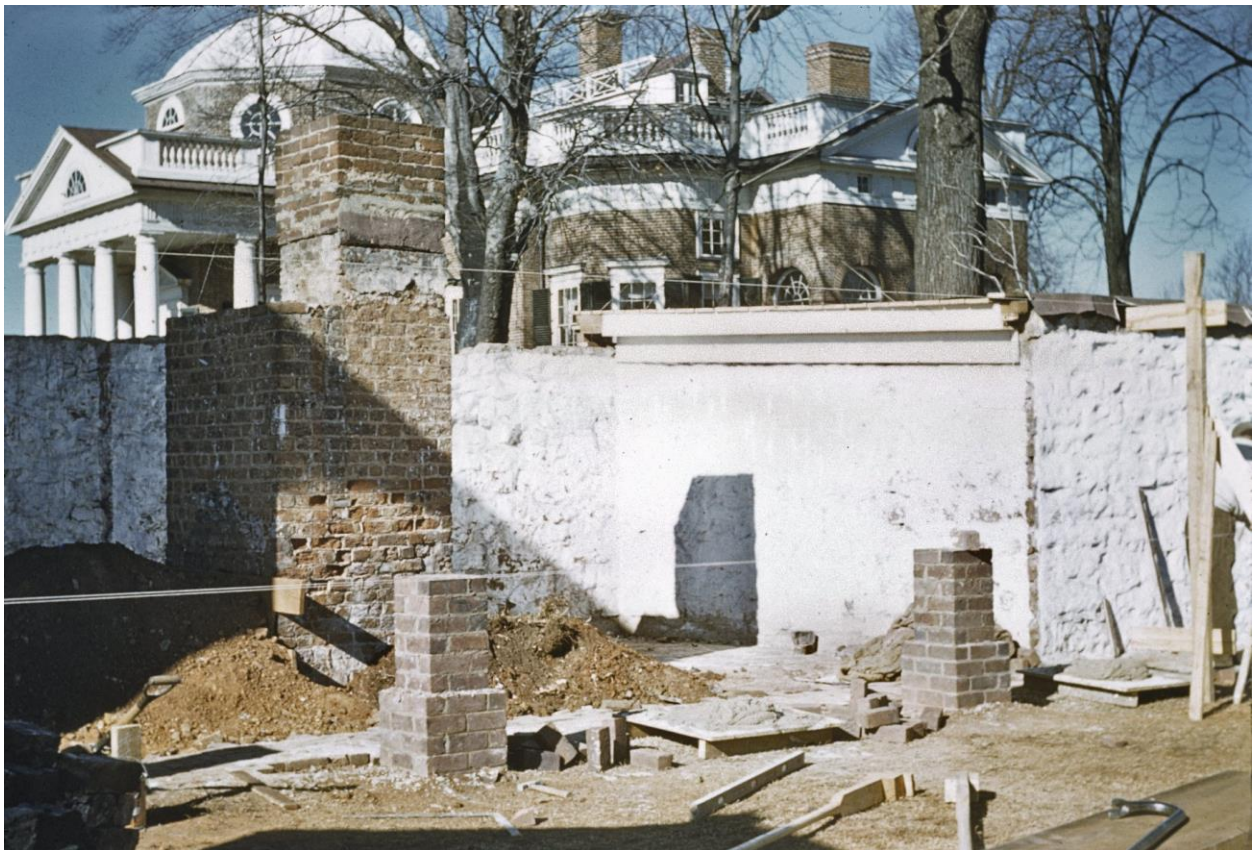
Figure 67: Photograph from 1941, looking northeast towards the east "servants room" (Grigg 1941k). This image records the rebuilding of the terrace and columns along the Wing and the excavation of dirt in the east and west "servant's" rooms.

In 1941, Milton Grigg's team tested the spaces under the Wing prior to the Thomas Jefferson Memorial Foundation installing a men's restroom in what was the east slave room and a women's restroom in what was the west slave room (Figure 67). Archaeologists excavated one of Grigg's cross trenches in the Dairy, which was oriented northeast to southwest (SG104 in F07), and other Grigg backfill deposits (also 2603G and H) also in the Dairy. Grigg's zig-zag cross trench may have intersected the 1770's stairs.
