The Archaeology of Monticello's South Pavilion and South Wing

By
Crystal O'Connor and Fraser Neiman
Monticello Department of Archaeology

Monticello Department of Archaeology Technical Report Series Number 7

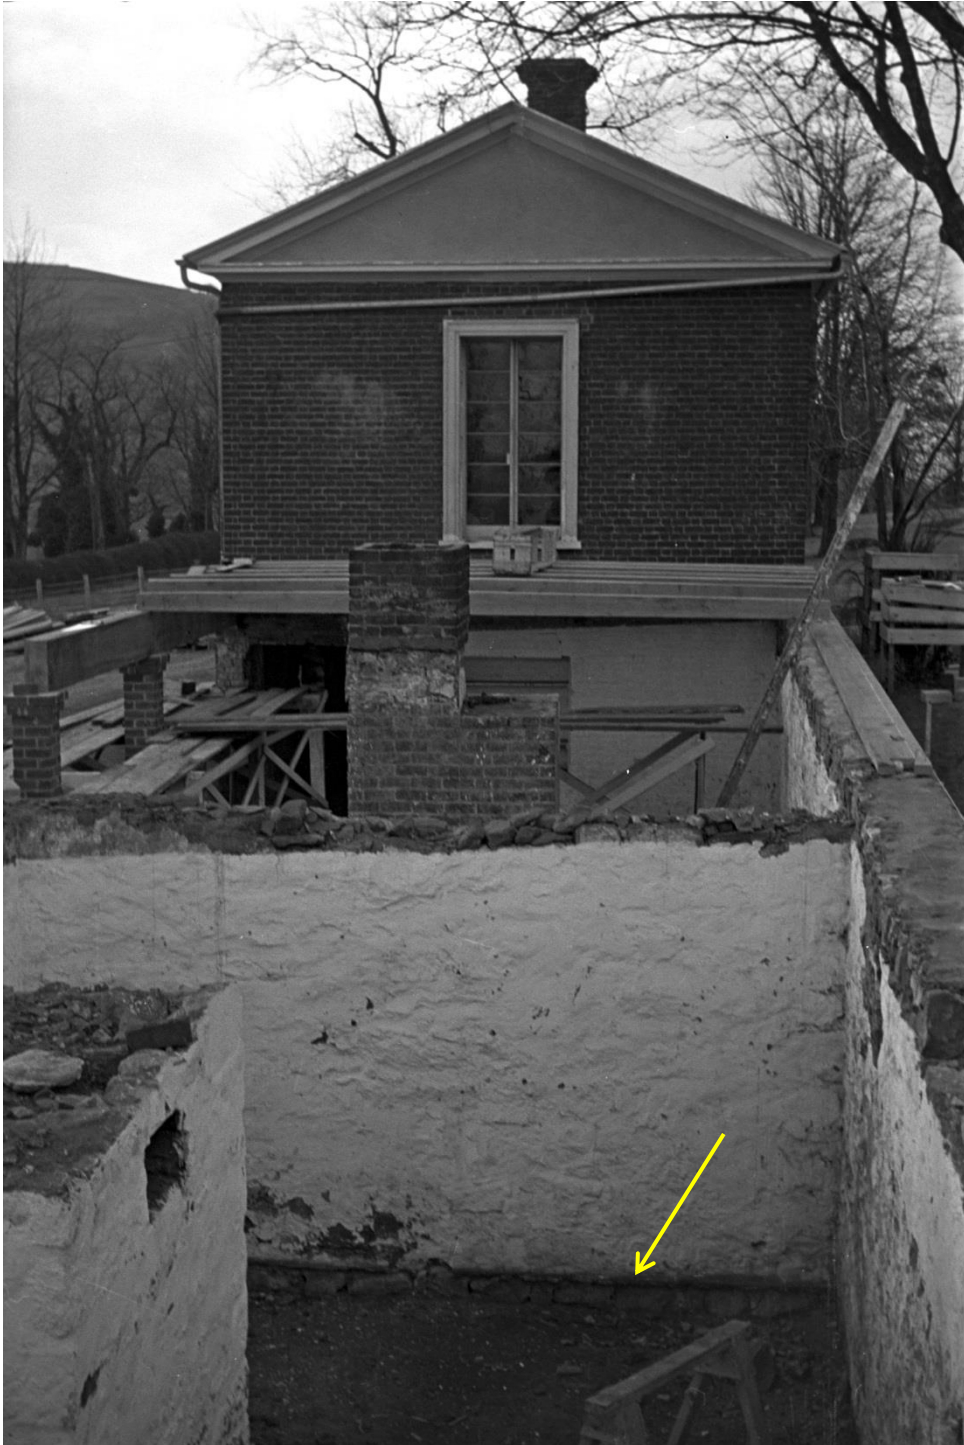
Figure 68: Photograph looking west of Milton Grigg's work in 1941 on the South Wing (Grigg 1941j). Note the stone footer exposed along the base of the wall in the Smokehouse dug by Grigg's team.

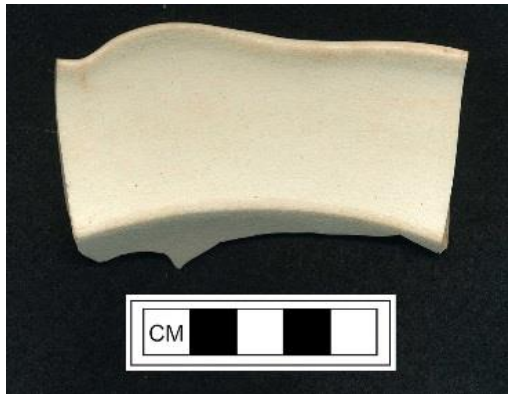
Figure 69: Creamware with Royal Pattern edge from context 2584S. The sherd is from SG14/F11 (Period 2 drainage ditch).

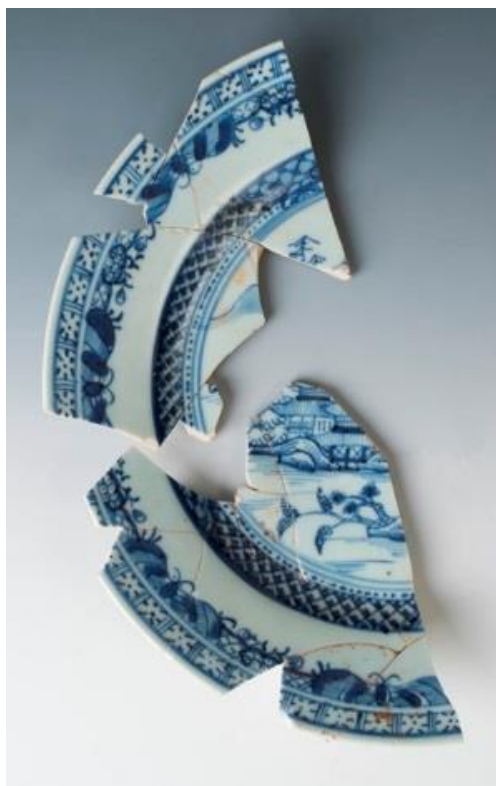
Figure 70: Chinese porcelain plate, hand-painted blue decoration, including a central landscape and house scene on the base; a stacked/adjacent combination border comprised of fish roe, trellis, and dot bands around the well; and a stacked/adjacent combination comprised of a trellis band, butterflies, and cartouches near the rim. Unidentified pattern that matches objects from other sites at Monticello, including Building o, Stewart-Watkins, and Mansion Foundation sites. Sherds are from contexts 2582F, 2583E, 2583F, 2584D, 2586C, 2587B, 2588D, 2588F, 2589C, and 2614B. Sherds come from SG28 (1808 fill); SG47/F01 (1967 pipe trench), and Grigg's backdirt (2582F).

Just under half of the ceramics have decoration (n=779, or 45%), the majority of which, when combined, are handpainted blue and overglaze Chinese Porcelain (n=367, or 21%; Figure 70, Figure 71, Figure 72). Ceramic genres, or decoration, among decorated sherds include but are not limited to blue transferprint, sponge/splatter, overglaze, factory made slipware, shell edge, and molded edges (Table 18).

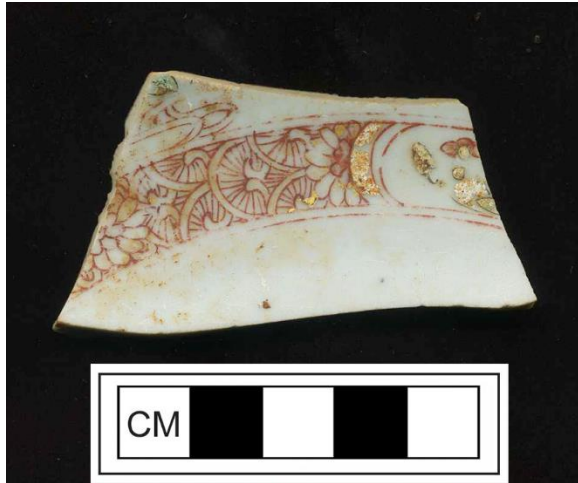
Figure 72: Overglaze, handpainted Famille Rose Chinese porcelain plate fragment from context 2591B. The sherd comes from SG47/F01 (1967 pipe trench). Pattern matches a different object from Building o that was likely from the same service. While the Famille rose pattern dates from the 1720s–1795 (Litzenburg 2003:36), this example was identified by Senior Curator of Ceramics and Glass Leslie Grigsby at Winterthur to be from the 1770s or 1780s.

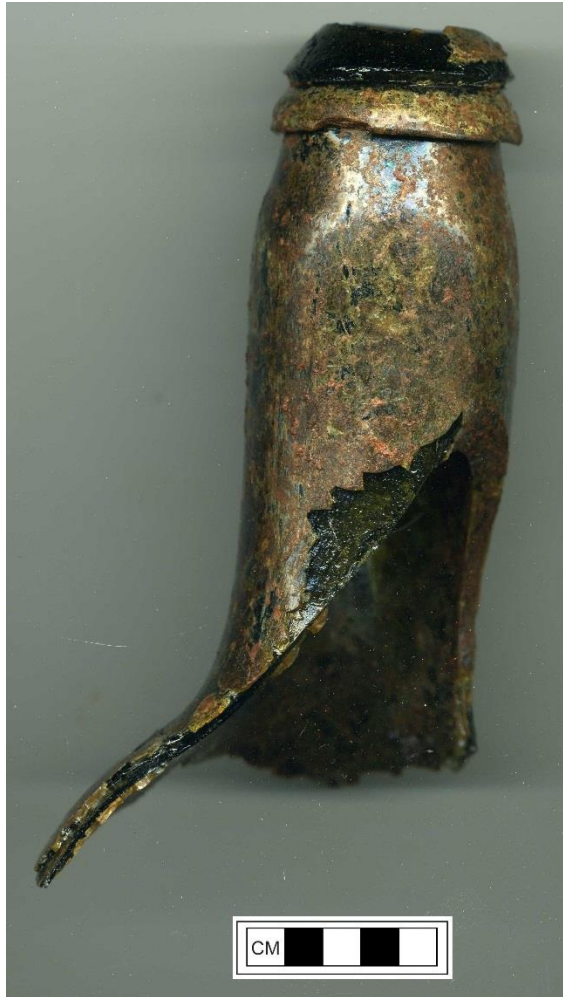
Figure 73: Shoulder, neck, and finish of a severely patinated green wine bottle from context 2584D. Lip and string rim are both down-sloped, and neck is bulge-shaped. The shard comes from SG28 (1808 fill).

Some of these shards were leaded glass (n=261, 13%) (Table 21). The assemblage (Table 22) is dominated by wine bottles (n=1,136, 56%) (Figure 73).

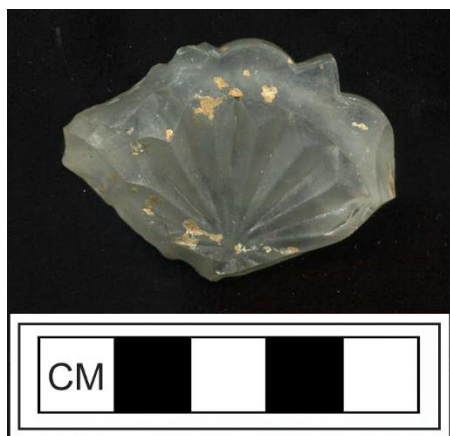
Figure 74: Clear leaded tumbler base with molded sunburst design from context 2581E. The tumbler base comes from SG34/F03 (Grigg's backfill).

Mouth blown glass shards (89%, n=1,801) heavily dominate the glass assemblage. There are much smaller amounts of machine made glass shards (n=2, 0.1%), mold blown shards (n=124, 6%), such as a tumbler base with a starburst design (Figure 74), and free blown shards present (n=1, .05%) (Table 23).

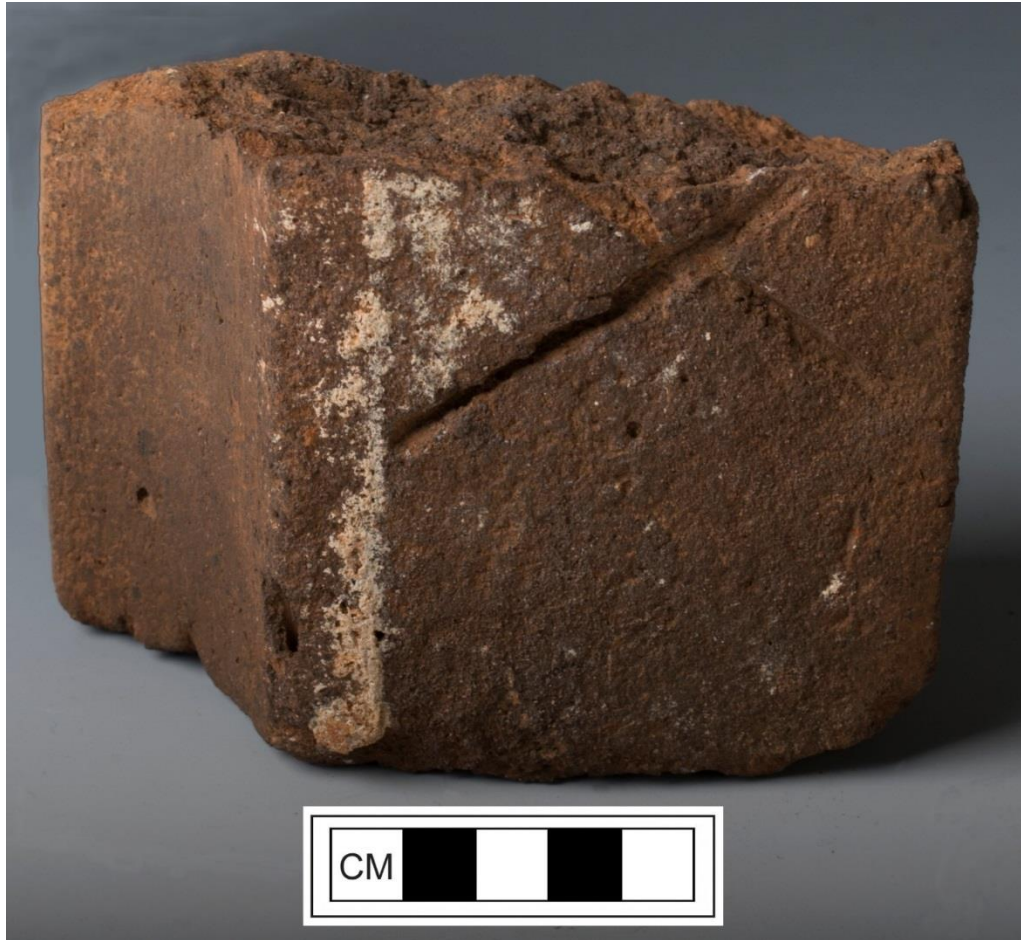
Figure 75: Water table brick with mortar and an incised X from context 2589B. The brick comes from SG42 (Grigg's backfill). The presence of mortar may suggest that this brick was from Monticello I.

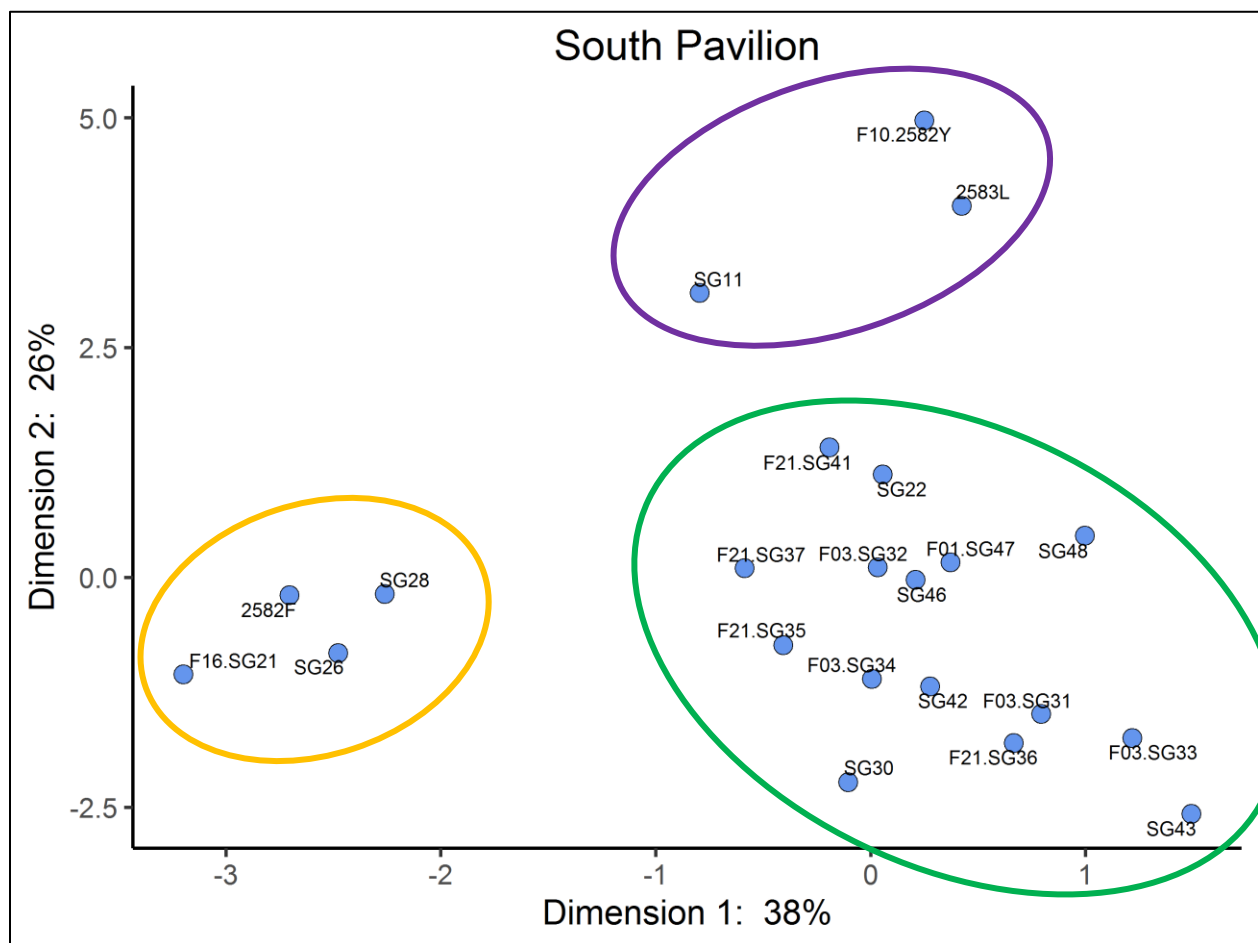
Figure 91: Correspondence analysis. Dimension 1 versus Dimension 2 scatter plot. Note the three clusters. Orange is Cluster 1; purple is Cluster 2; green is Cluster 3.

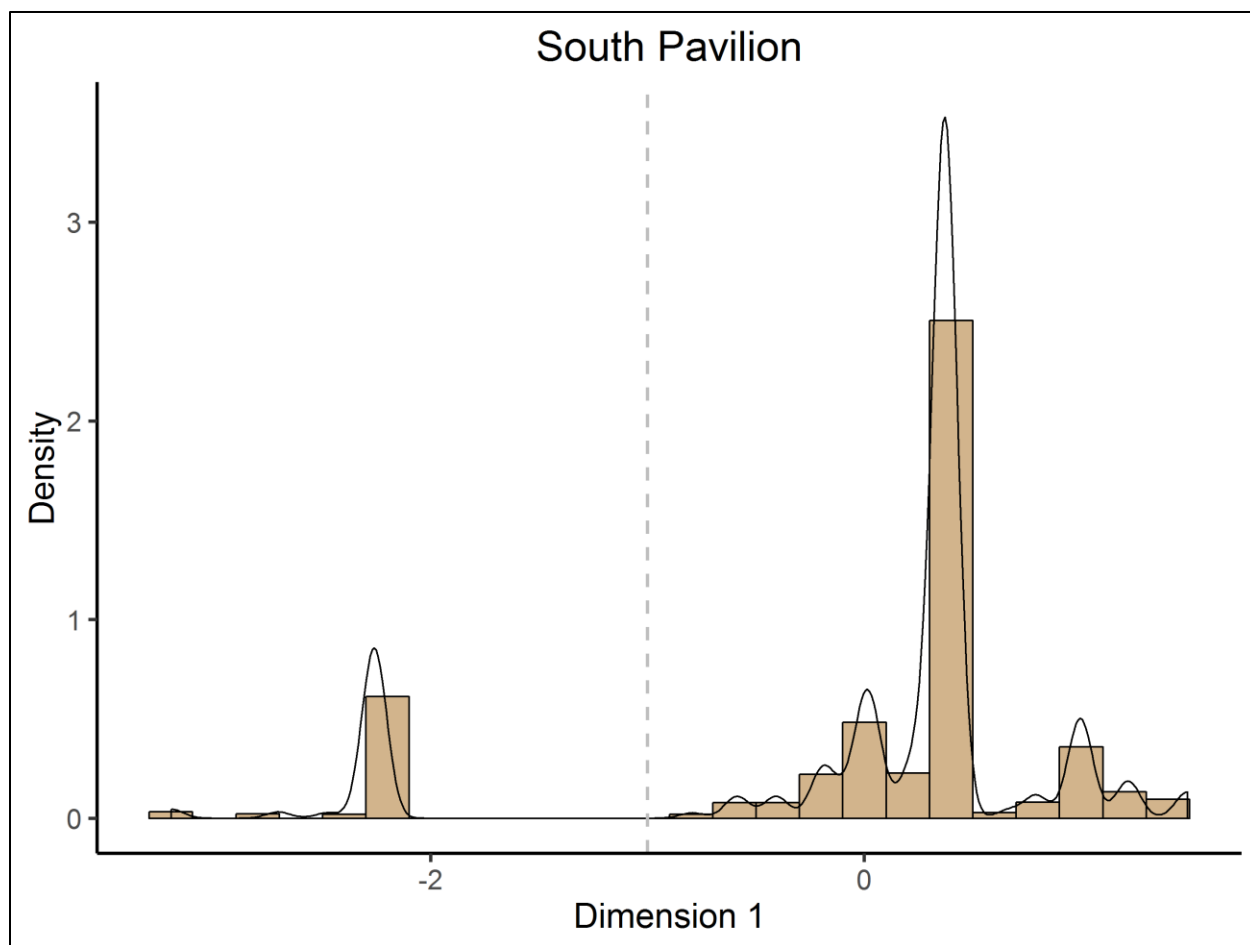
Figure 95: Weighted histogram of ceramics from the South Pavilion plotted along CA Dimension 1. The vertical line indicates phase divisions. The value set for the phase was set at -1.5.

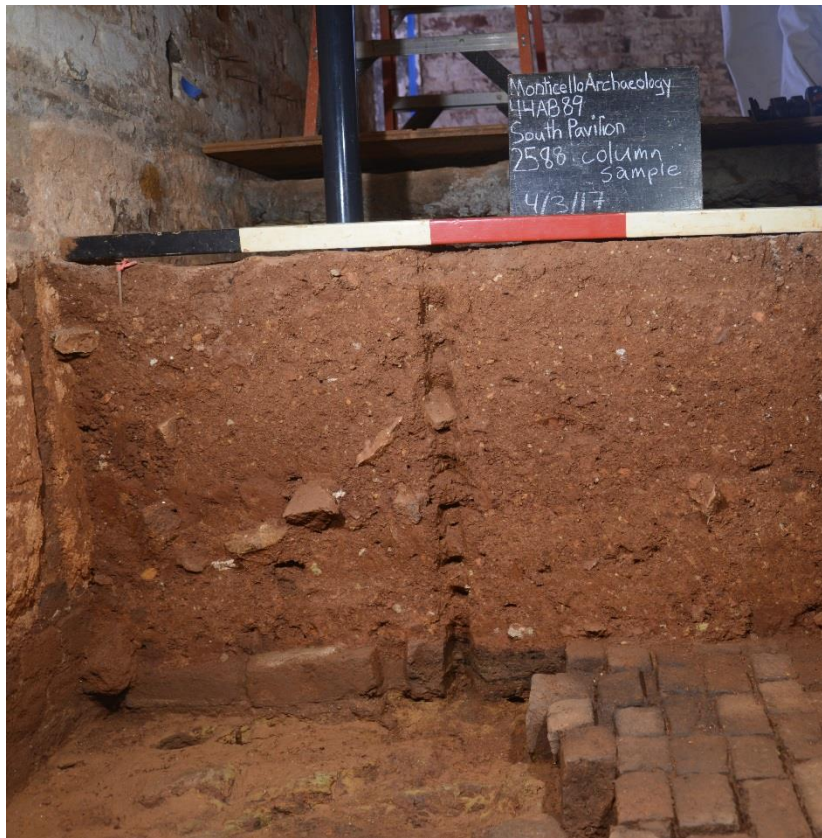
Figure 99: 2588 column sample. View south. See Figure 47 for the measured drawing.

We collected 64 pollen samples from the South Pavilion. The 23 samples used in this analysis are listed and described in Table 31. These samples include sediment from a column in the south profile of 2588 (Figure 99; Figure 47 for the measured drawing) and two samples from the pit in 2582 (Feature 10; Figure 100; Figure 36 for the measured drawing). We wanted to see whether taxon frequencies in pollen from the 1808 fill differed from frequencies in layers dating to the use of the space as a kitchen.

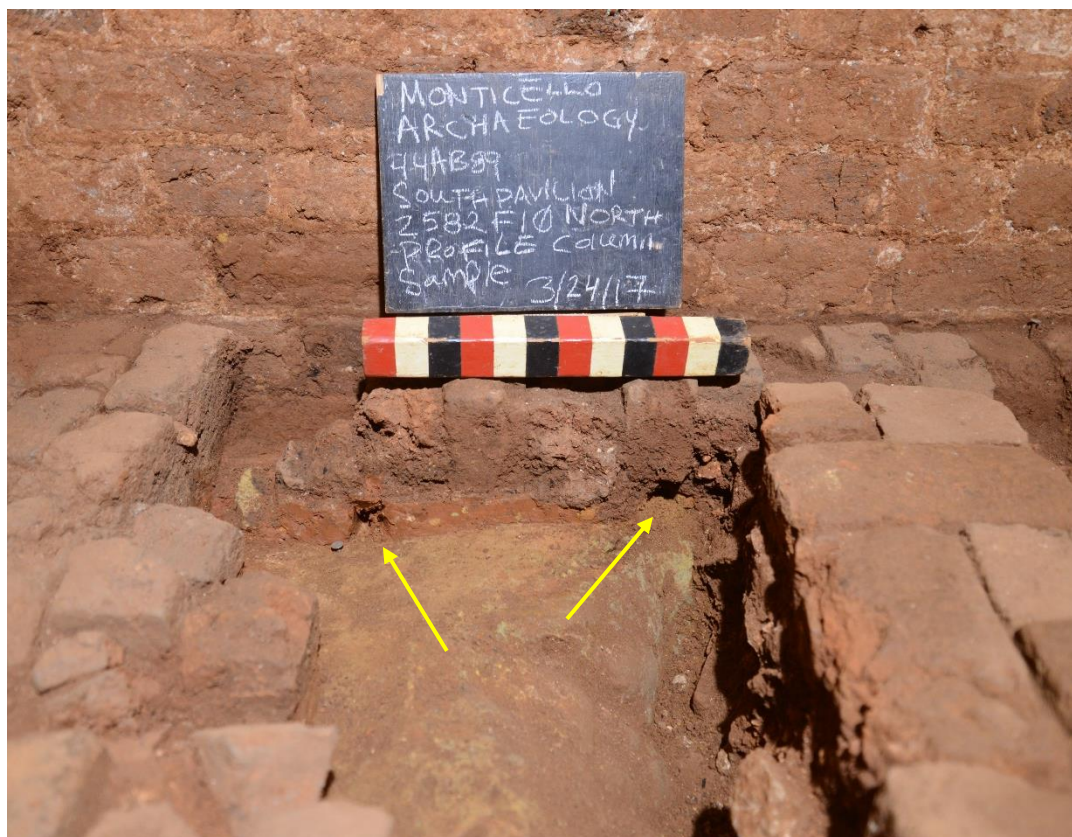
Figure 100: 2582 column sample. View north. The yellow arrows mark sample locations. See Figure 36 for the measured drawing.

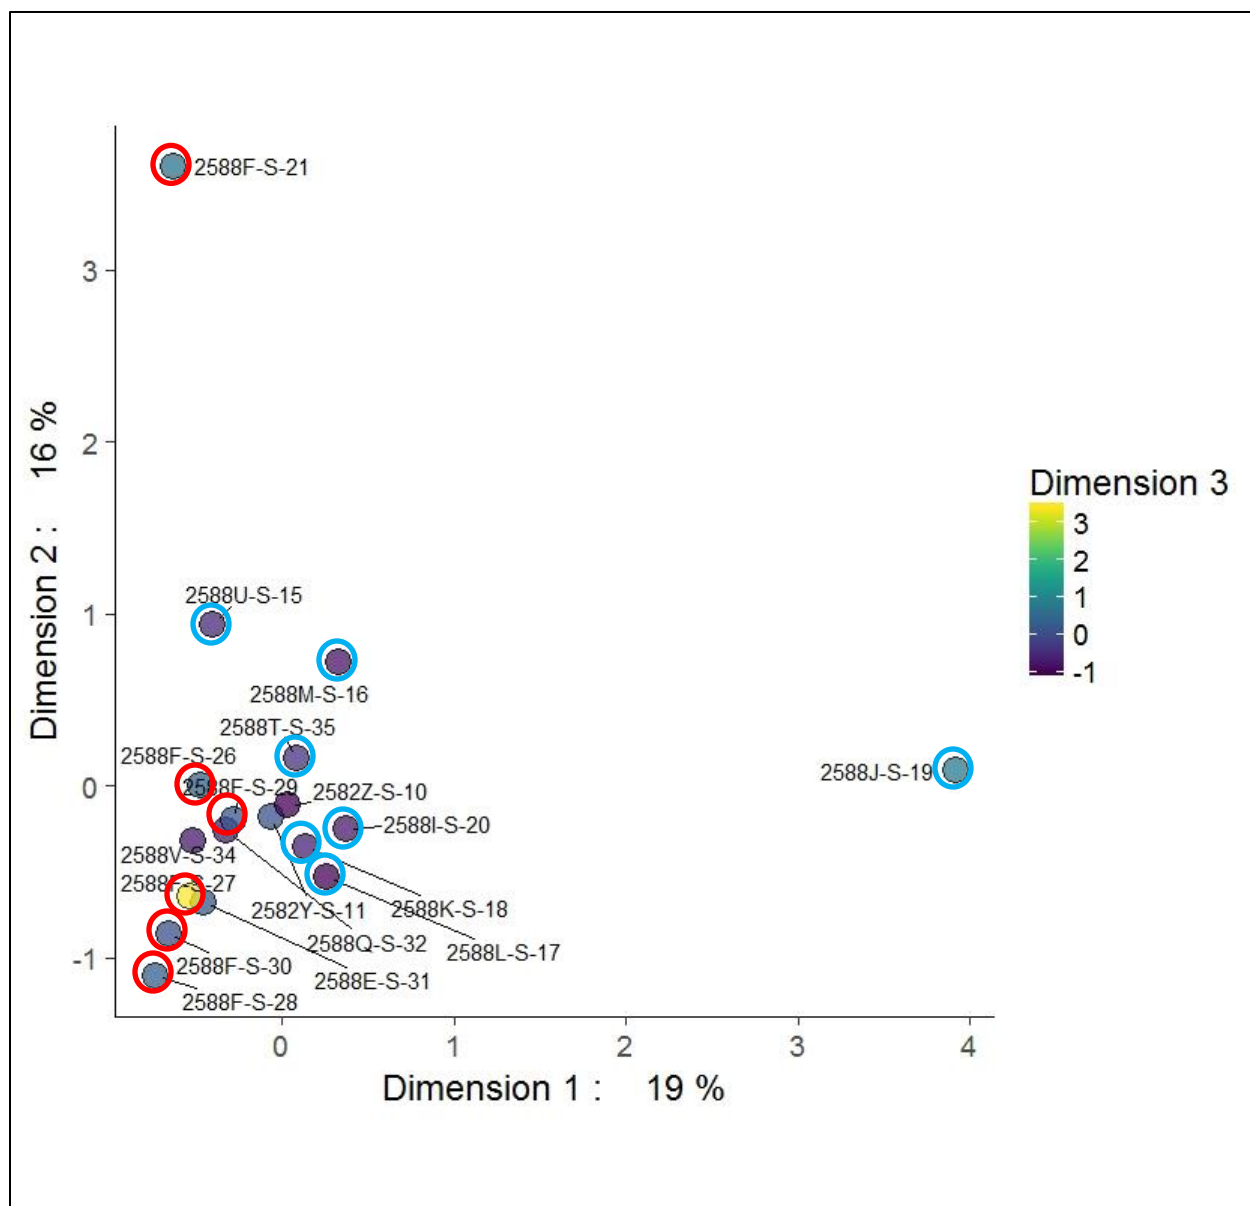
Figure 103: Correspondence analysis of pollen data from the South Pavilion. A red circle indicates the sample is from the 1808 fill. The blue circles indicate the sample is from the drainage ditch.
