Architectural artifacts being catalogued

Monticello's Restoration Department is currently in the process of formally accessioning its extensive collection of architectural artifacts accumulated during restoration projects over the years.

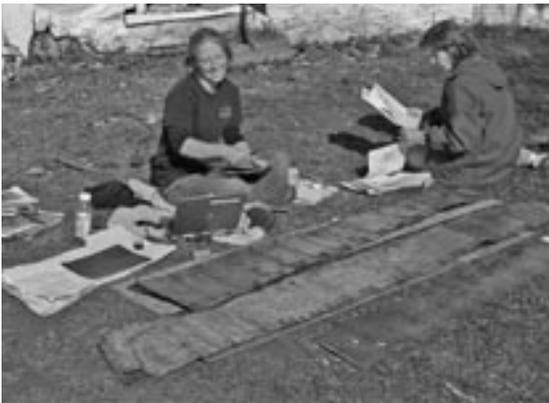
Above, Jodi Frederiksen (left) and Carol Richardson examine tin-plated iron shingles from Monticello's dome.

For instance, there are Jefferson-era tin-plated iron shingles from Monticello's dome. Applied in the early 1820s, many of these shingles bear inscriptions scratched into the surface by visitors from the late 1820s and early 1830s. They remained encapsulated under later re-roofings until 1955, when they were carefully removed and stored in the Mulberry Row stable. Although the shingles were examined during the roof restoration of 1991-92, the inscriptions were not researched. This past fall, Frederiksen and Carol Richardson, a Monticello restoration specialist, were able to decipher and photograph approximately half of them. Research by Frederiksen has revealed that about one-third of these legible signatures belonged to students at the University of Virginia, and she plans to do additional research into the identities of these students and other individuals.

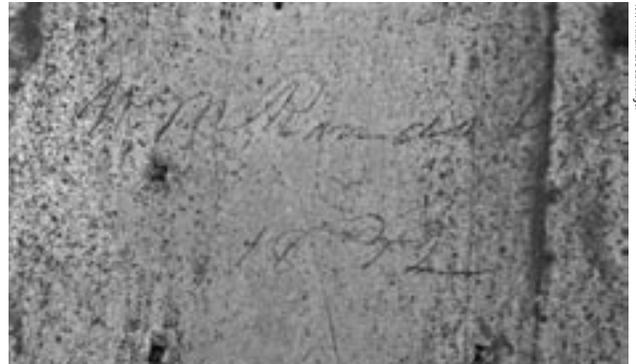
Many of the shingles bear legible inscriptions made by visitors in the late 1820s and early 1830s.
